**ANALYSIS OF BROWNFIELDS CLEANUP ALTERNATIVES &  
CONCEPTUAL REMEDIAL ACTION PLAN  
BRADBURY MANOR  
74 HIGH STREET  
BELFAST, WALDO COUNTY, MAINE**

Project 111.06134.086  
October 1, 2024

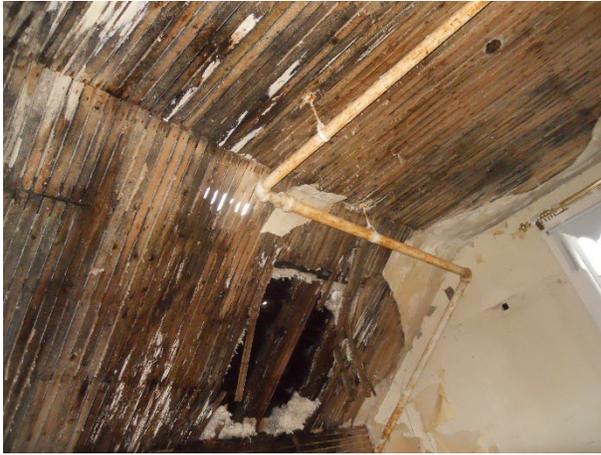
1) Collapsed finishes and saturated framing from water intrusion at the roof.

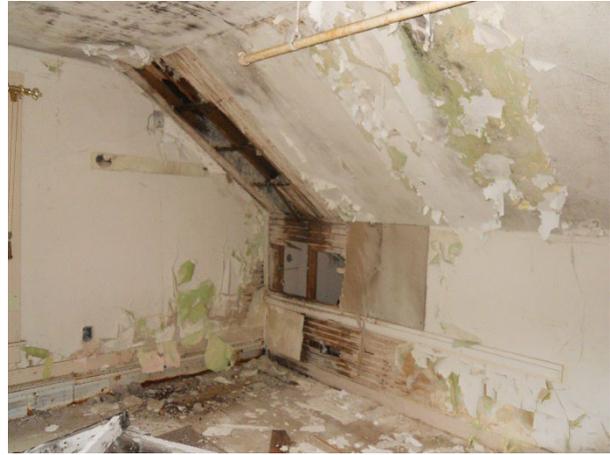
2) Collapsed finishes and mold from water intrusion at the roof.

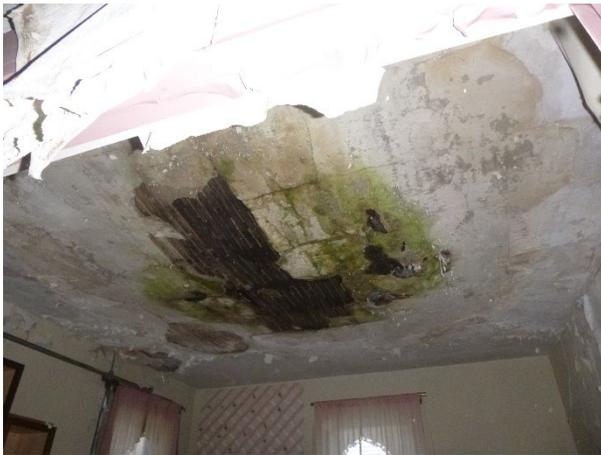
3) Collapsed finishes and mold in the third floor from water intrusion.

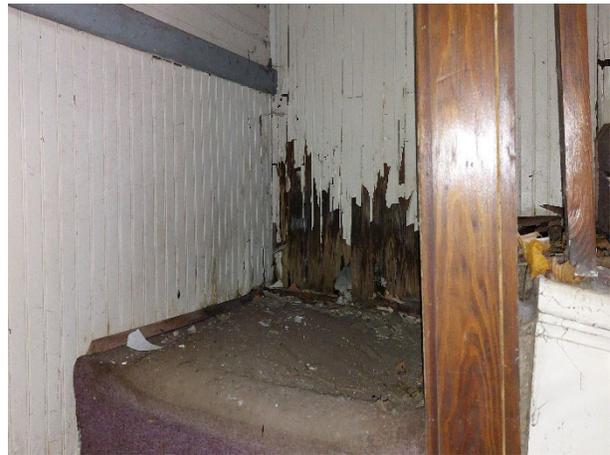
4) Failing stair landing between the basement and first floor.

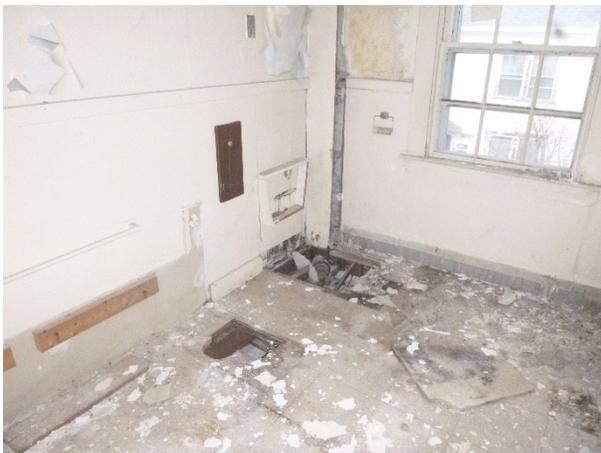
5) Multiple holes are present in the floors.

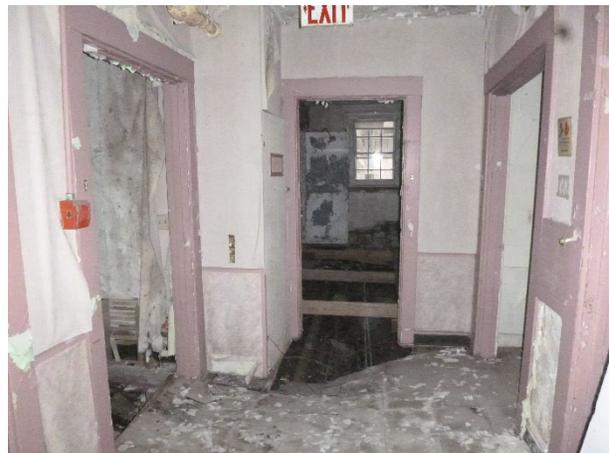
6) Partially collapsed first floor on the west side of the building.
