# FIRE STATION FACILITIES ASSESSMENT AND SITE FIT PLAN

**City of Belfast**  
**Public Safety Facility – Police/Fire/EMS**  
**Belfast, Maine**

**March 5, 2025**

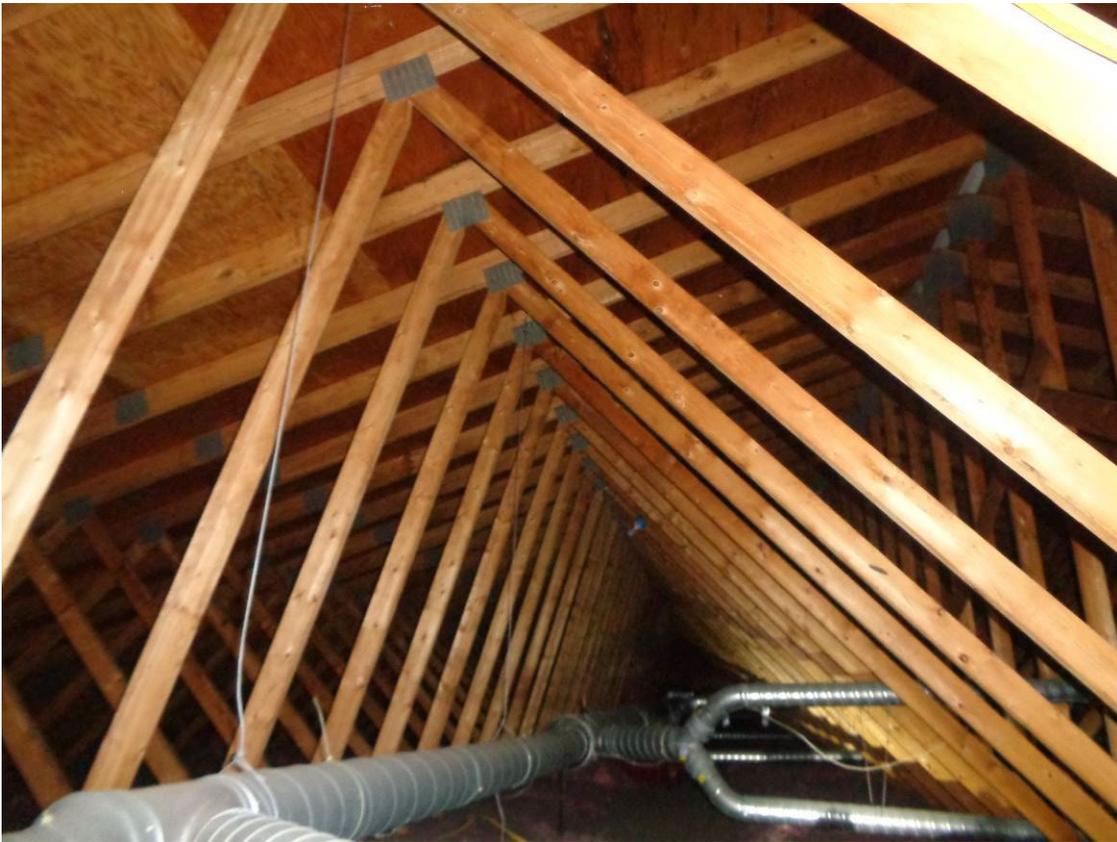
The original fire station is a single-story building with a gable roof, framed with pre-engineered metal plate-connected wood trusses at approximately 2-feet on-center (refer to Structural Photo S1 in Appendix A). Roof sheathing is plywood roof sheathing. Although the exterior wall framing was not visible during the walk through of the building, it is assumed that the exterior walls are 2x wood framing with exterior plywood wall sheathing. The foundation walls are concrete and extend approximately 2-feet above the finished floor on the back and sides of the building. At the front of the building, where the overhead doors are located, the top of the foundation wall is at the elevation of the finished floor. At the perimeter of the foundation wall, multiple cracks were visible. The cracks appear to be shrinkage cracks.

Structural Photo S1 – Fire Station, Roof Framing and Plywood Roof Sheathing

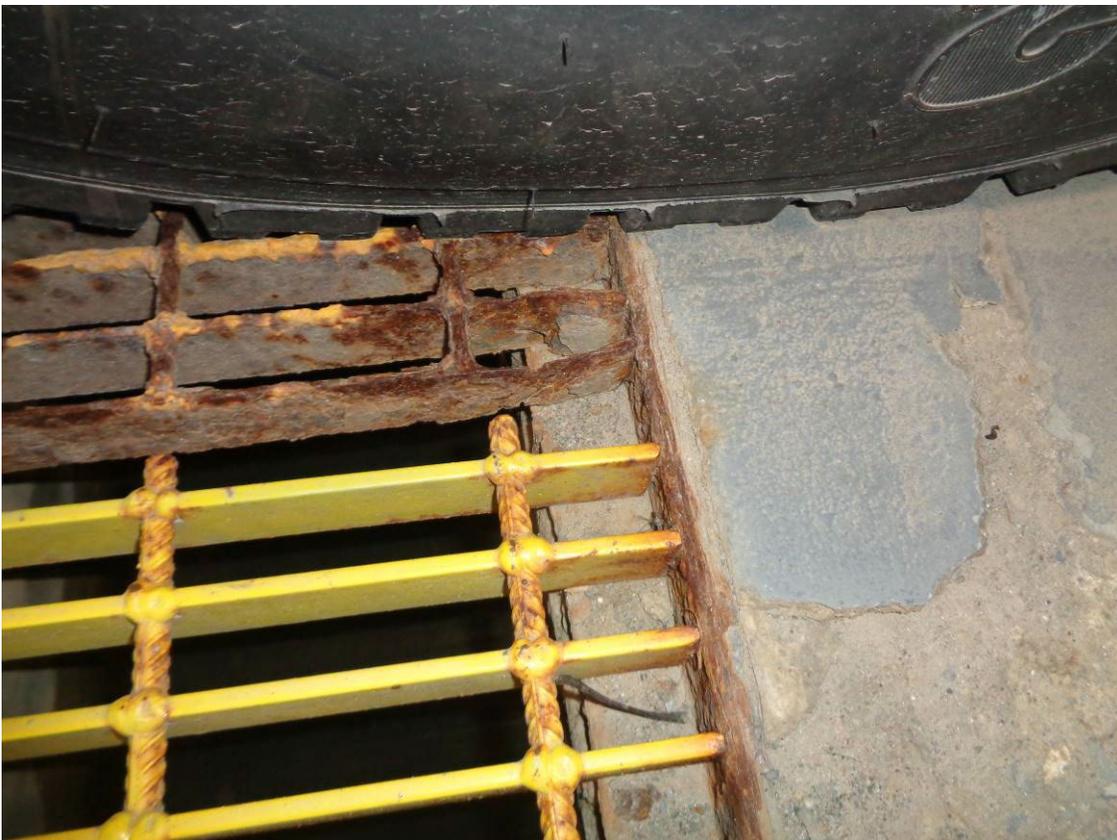
The floor is a concrete, slab-on-ground and pitched to a trench drain located at the middle of the building. The trench drain is covered with steel-painted grating with an embedded steel angle supporting the grating. The grating and the embedded steel angle are showing signs of corrosion (refer to Structural Photo S2). In addition, the concrete is cracking/spalling at the edge of the trench drains at multiple locations (refer to Structural Photo S3). There are also shallow troughs cut into the slab in the apparatus bay that terminate at the trench drain. The troughs appear to aid in the drainage of excess water (refer to Structural Photo S4).

Structural Photo S2 – Fire Station, Trench Drain Grating Corrosion

- Steel lintel corrosion at brick openings.
- Embedded steel angle sill corrosion at overhead doors.
- Steel corrosion at interior trench drain.
- Concrete damage at interior trench drain.

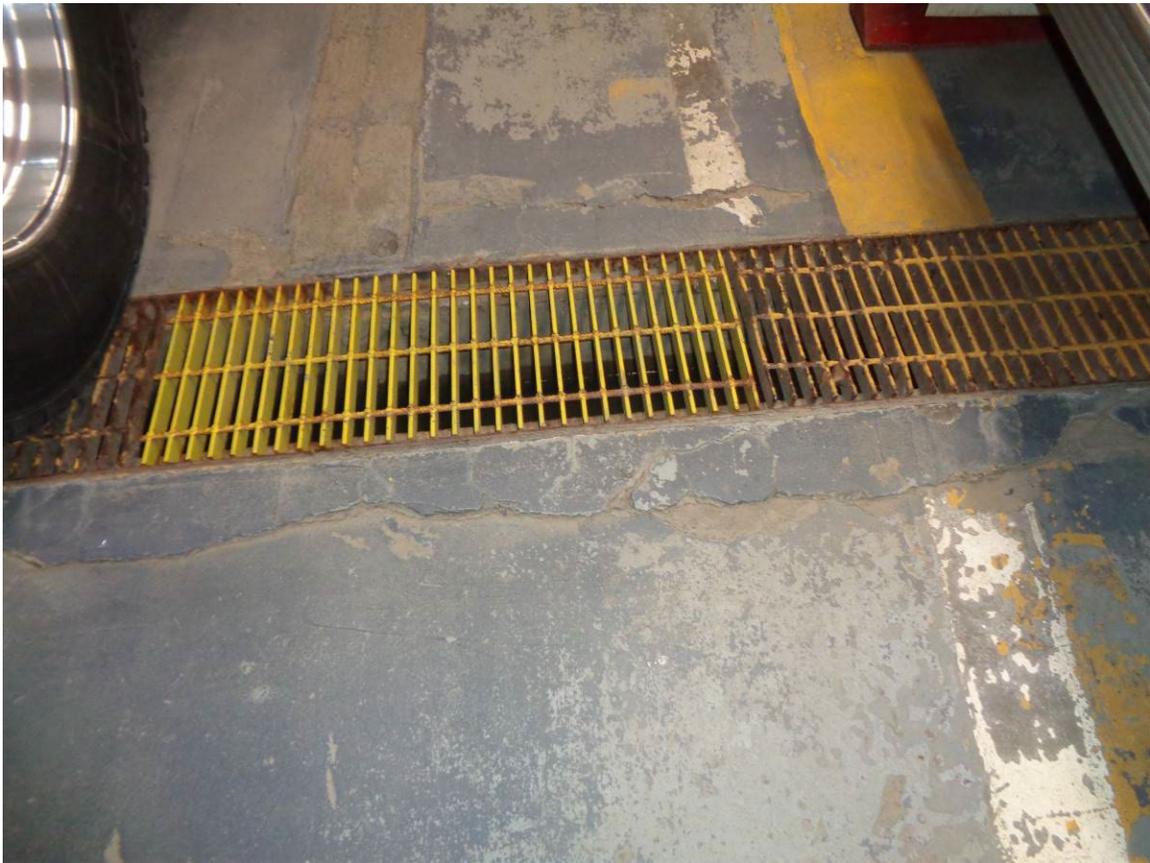
Structural Photo S3 – Fire Station, Trench Drain Concrete Damage

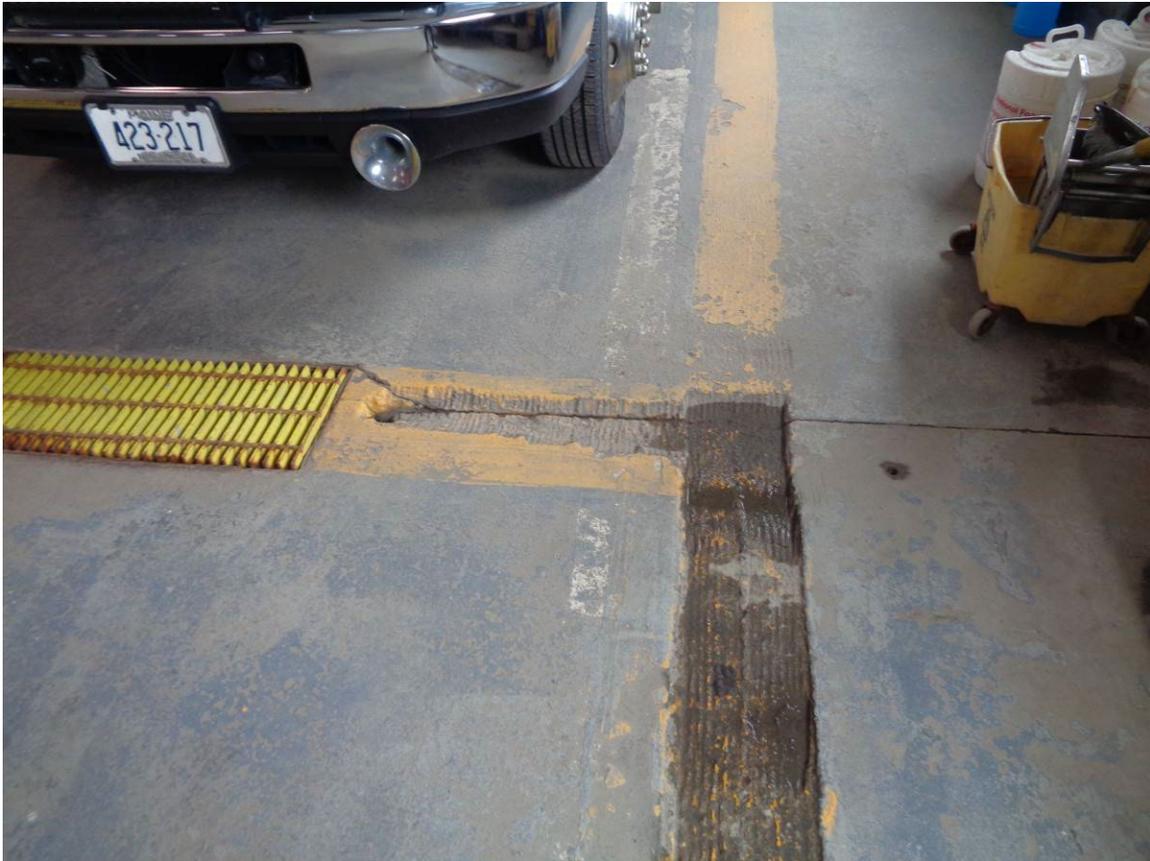
Structural Photo S4 – Fire Station, Troughs Ground Into Concrete

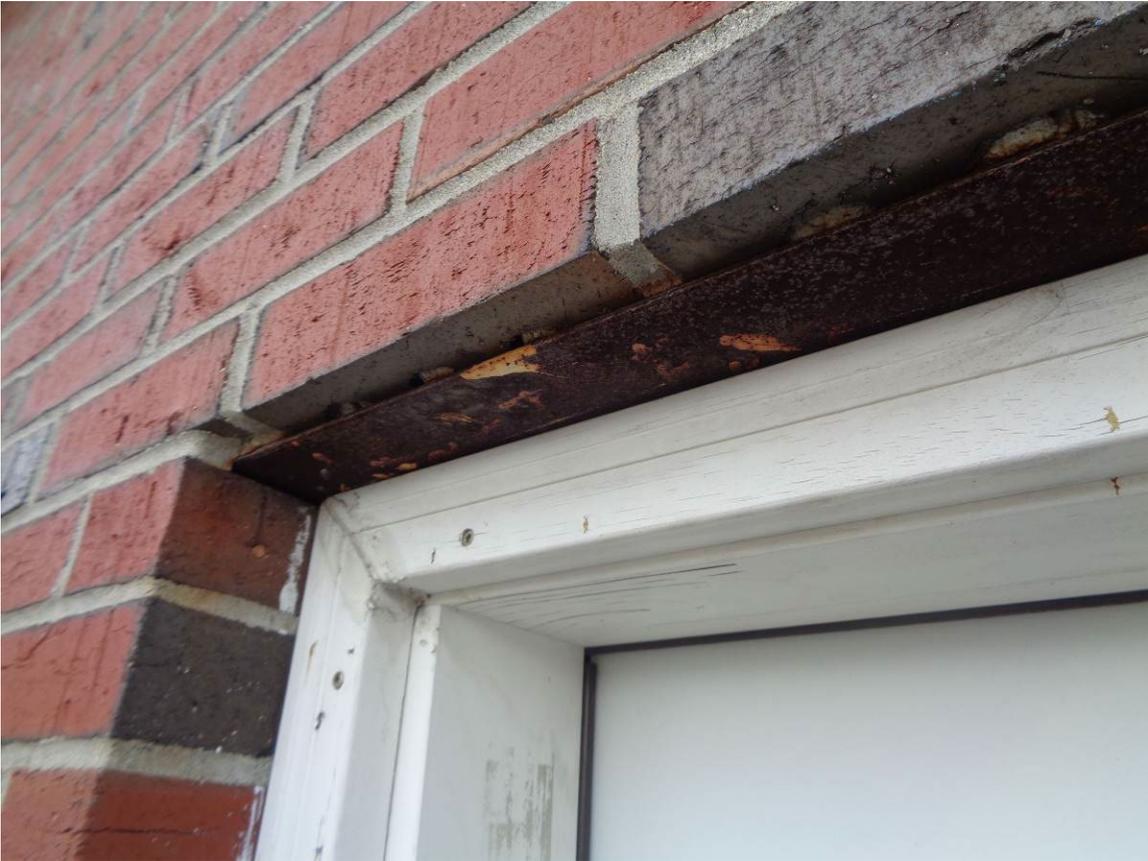
At the front of the original building, the wall is clad with a brick façade. The brick is supported by steel angle lintels over the door openings and the steel lintels are showing signs of corrosion (refer to Structural Photo S5). In addition, the overhead

Structural Photo S5 – Fire Station, Door Lintel Corrosion

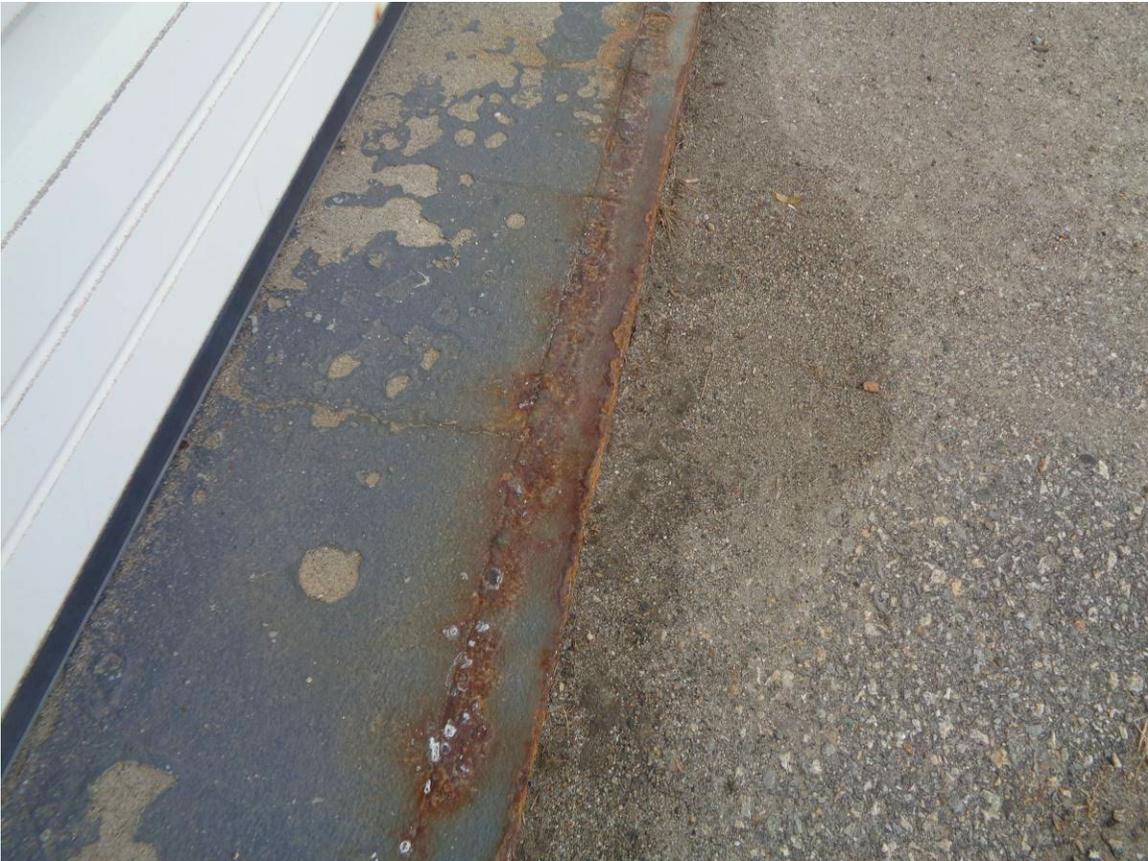
door sills have embedded steel angles at the edge of the concrete at the door openings. The embedded steel angles are also showing signs of corrosion (refer to Structural Photo S6).

Structural Photo S6 – Fire Station, Overhead Door Sill Corrosion

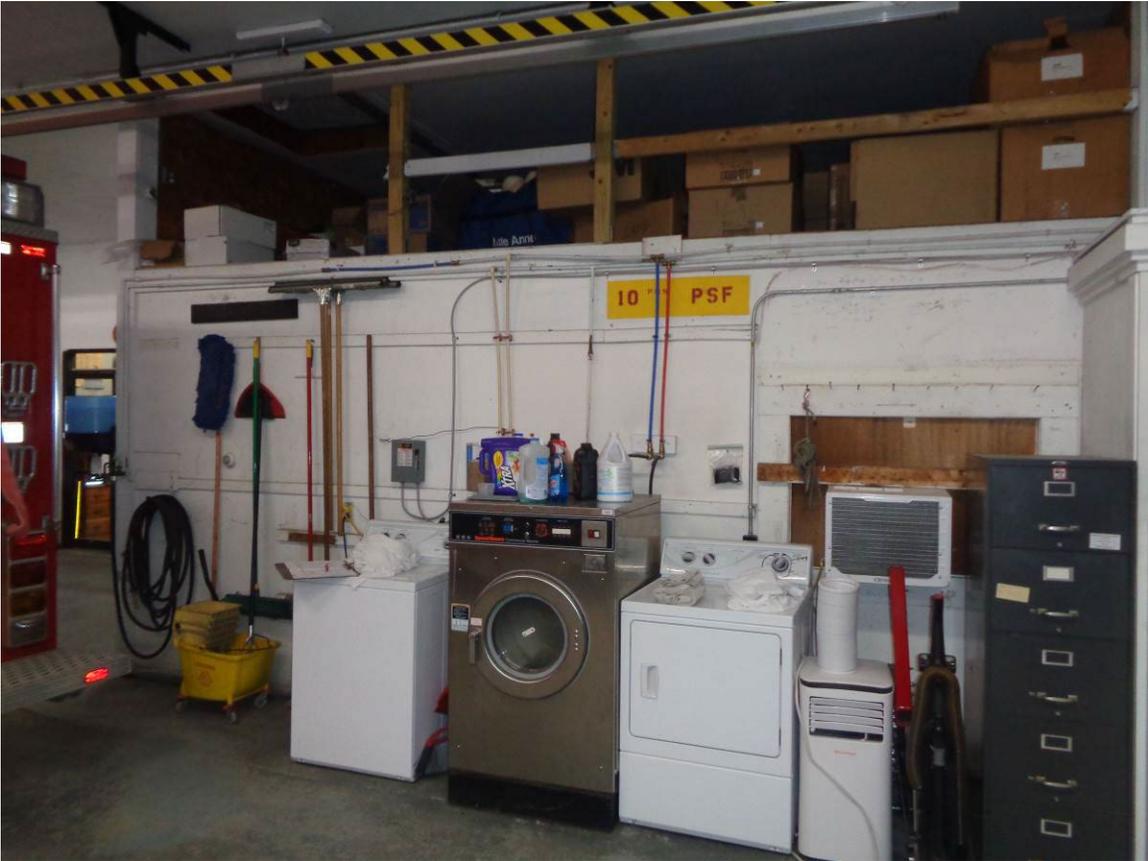
In the original building, there is a storage mezzanine above the ceiling of the bathrooms and kitchen areas. There is a sign on the wall below the mezzanine noting the capacity of the mezzanine of 10 pounds per square foot (refer to Structural Photo S7).

Structural Photo S7 – Fire Station, Mezzanine

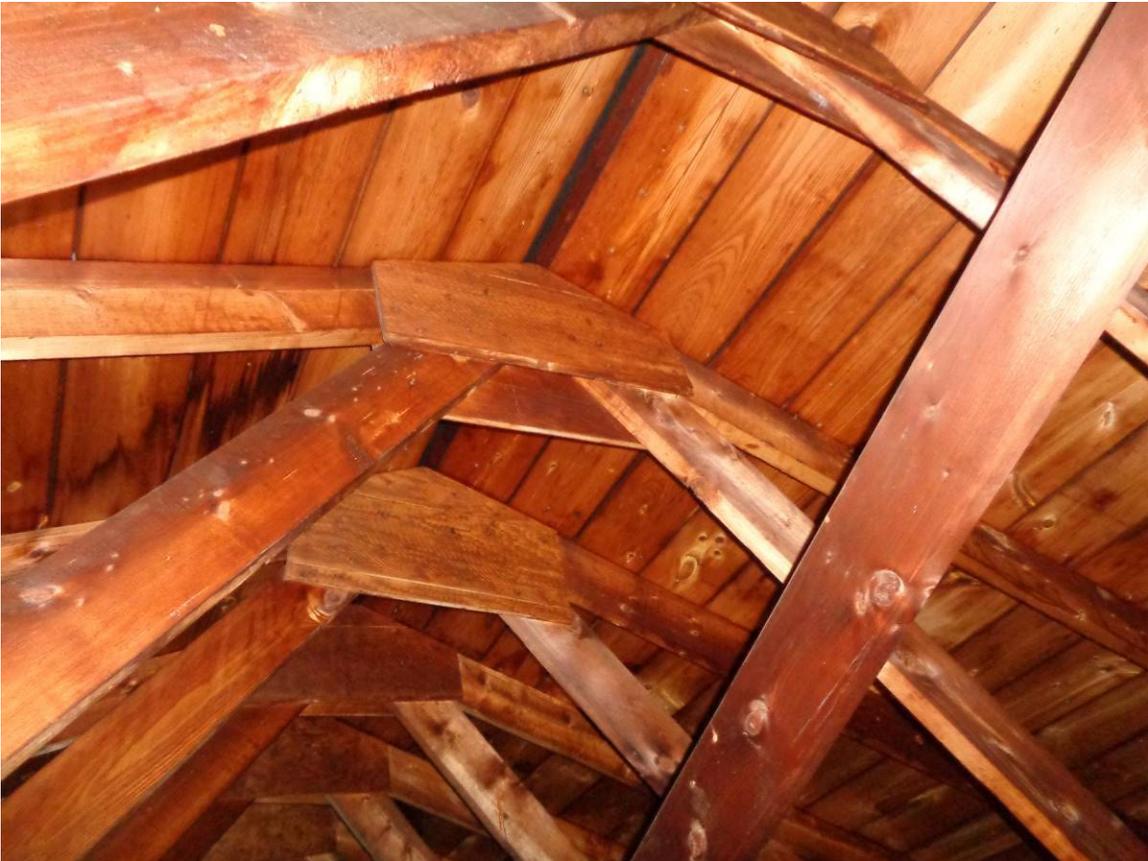
The museum building is a single-story building with a gable roof framed with a combination of wood trusses with wood gusset plates and 2x rafter framing at approximately 2-feet on-center (refer to Structural Photo S8). Roof sheathing is 1x

Structural Photo S8 – Museum, Roof Framing

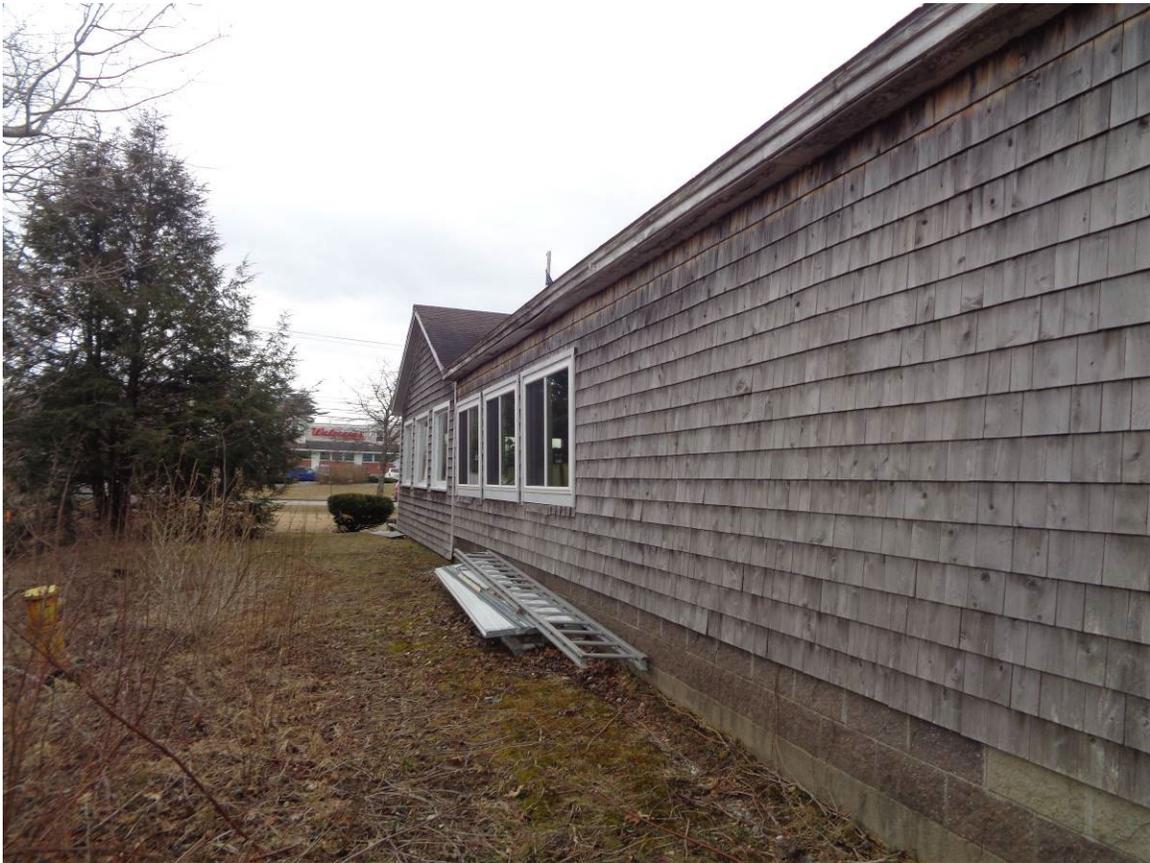
Structural Photo S9 – Museum, Exterior Wall Bow

- CMU cracking at masonry courses at bottom of exterior wall.
- East wall bowing at top of bearing wall.

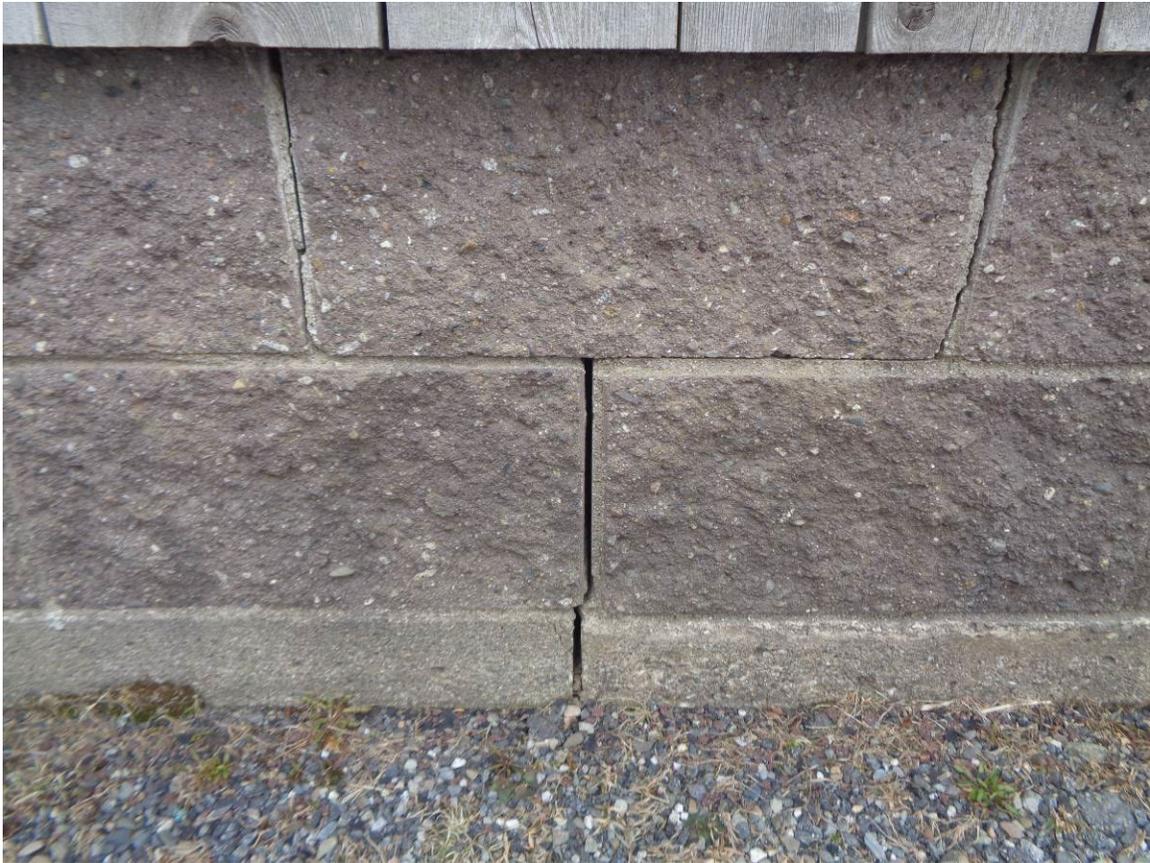
wood boards perpendicular to the roof framing. The exterior wall framing is 2x6 wood studs at approximately 2-feet on-center. The north portion of the building is built with two courses of CMU between the foundation and the bottom of the stud wall. On the east and west walls, cracks were noted in the CMU (refer to Structural Photo 9). In addition to the CMU cracks, on the east wall, the top of the 2x stud bearing wall is bowing out (refer to Structural Photo 10). Most of the foundation is not visible, so the extent of the foundation system below grade is unknown. At the visible portion of the perimeter of the foundation wall, cracks and spalls were visible. The cracks do not appear to be structural.

Structural Photo S10 – Museum, CMU Crack

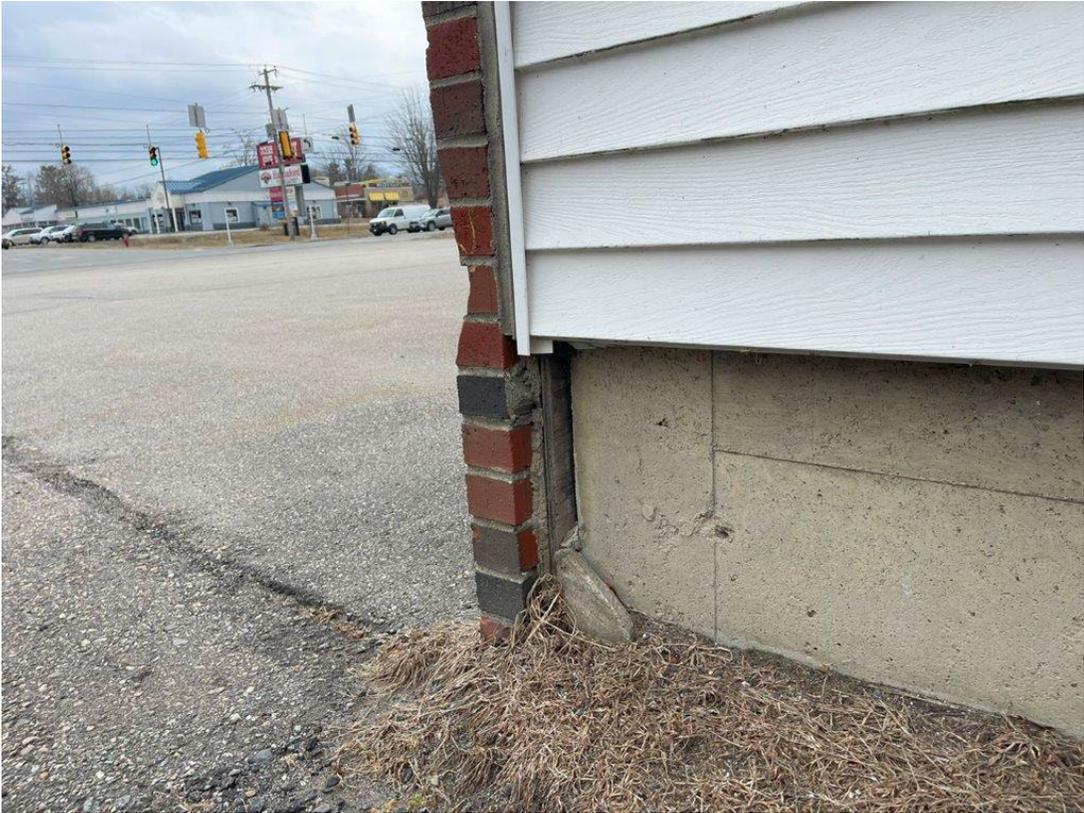
corner (refer to Architectural Photo A3). The existing fire station north, east, and west exterior walls consist of wood framing, batt insulation, plywood sheathing, and white vinyl siding (refer to Architectural Photos A4, A5, and A6). The vinyl siding is damaged at the corner trim at the northeast corner and at the east façade (refer to Architectural Photos A7 and A8). There appears to be a thin layer of rigid insulation behind the vinyl siding which is falling out (refer to Architectural Photo A9). The sectional doors have small oval vision windows, and the jamb tracks are severely rusted at the floor (refer to Architectural Photo A10). There is a single swinging man door on the south façade (refer to Architectural Photo A11). The building code requires a minimum of two means of egress from the apparatus bays and the office core. There are fixed and sliding windows on the east and west elevations. The original north and east walls have a two-foot high concrete knee wall with an exposed finish. The north and west walls of the addition have a two-foot high concrete knee wall with a fiberglass reinforced cementitious coating finish.

Architectural Photo A3 – Brick Veneer Damage

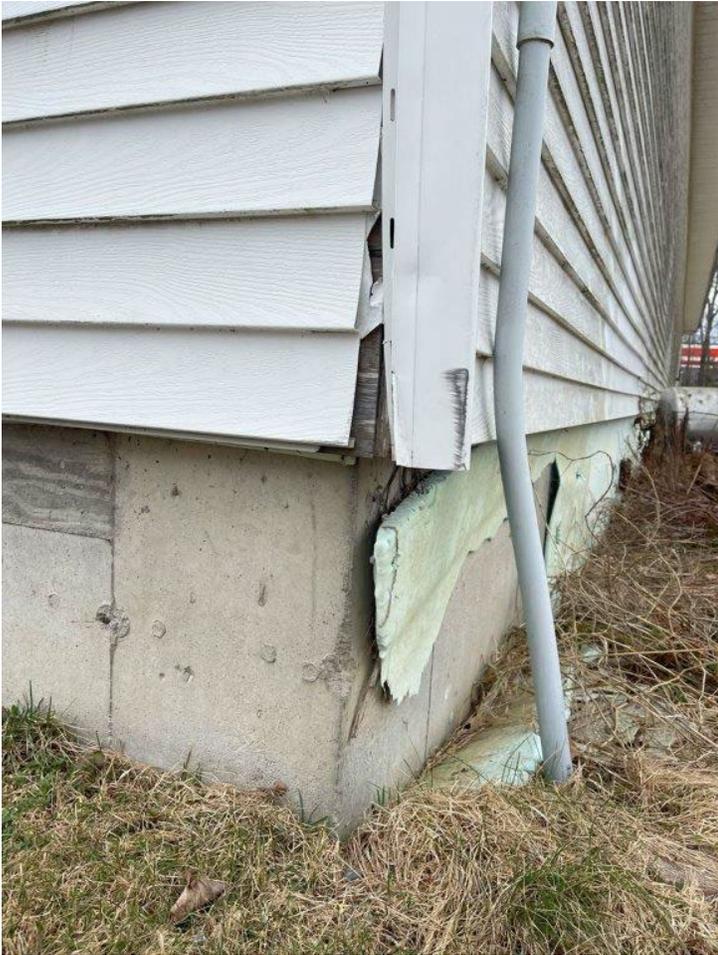
Architectural Photo A7 – Exterior Wall Insulation Damage

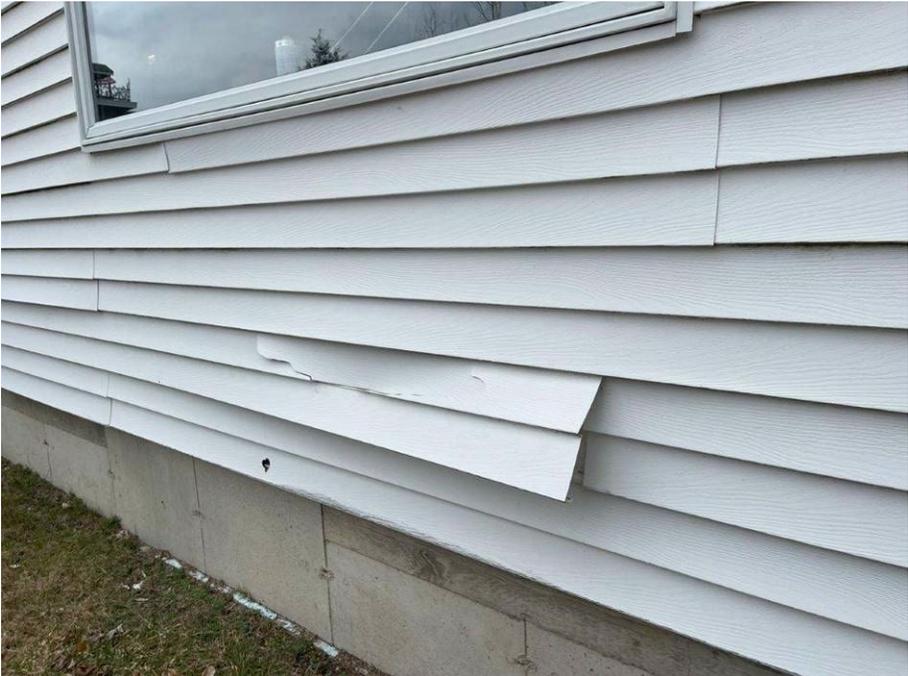
Architectural Photo A8 – Exterior Wall Siding Damage

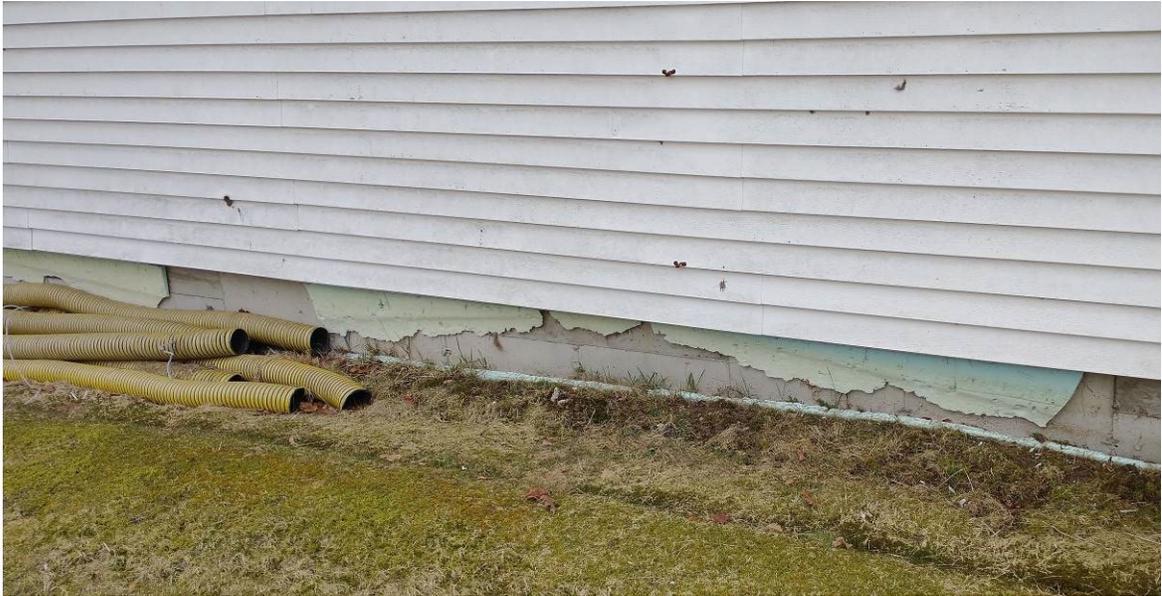
Architectural Photo A9 – Exterior Wall Insulation Damage

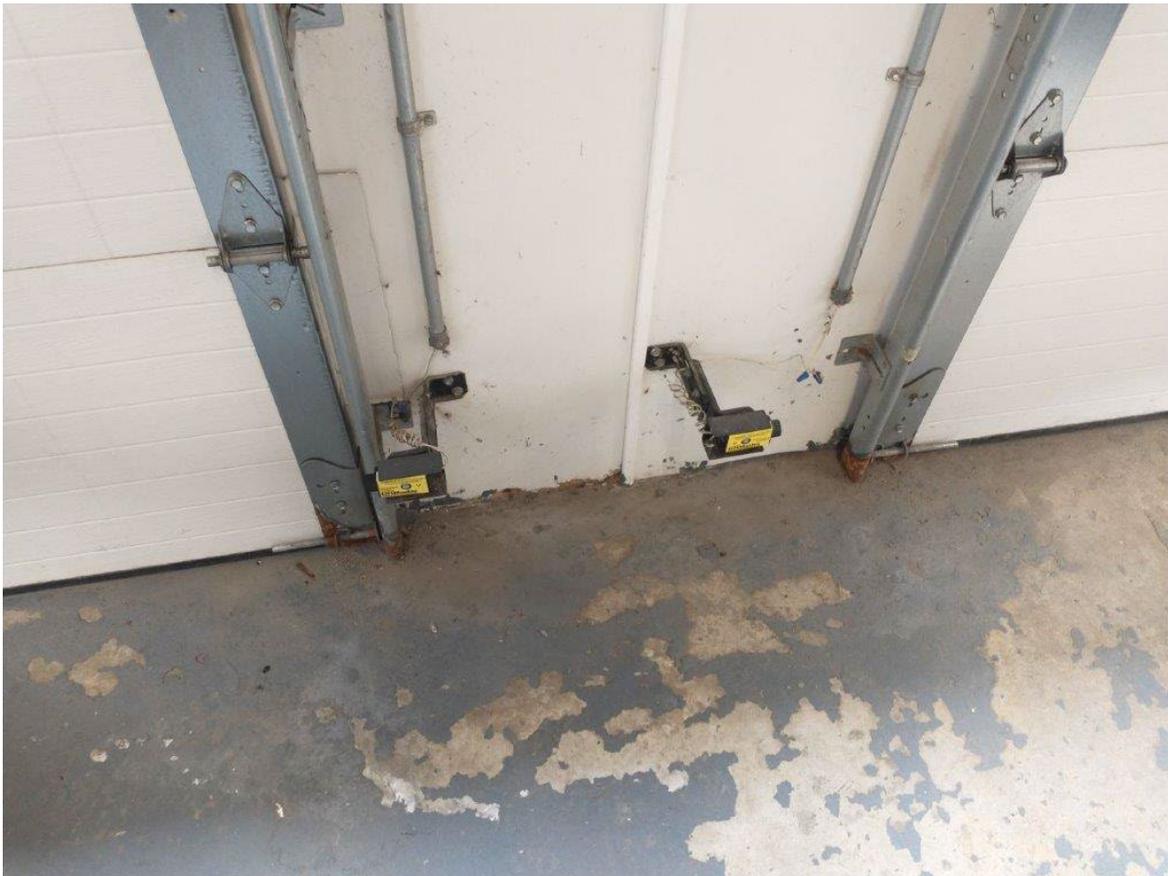
Architectural Photo A10 – Sectional Door Track Corrosion

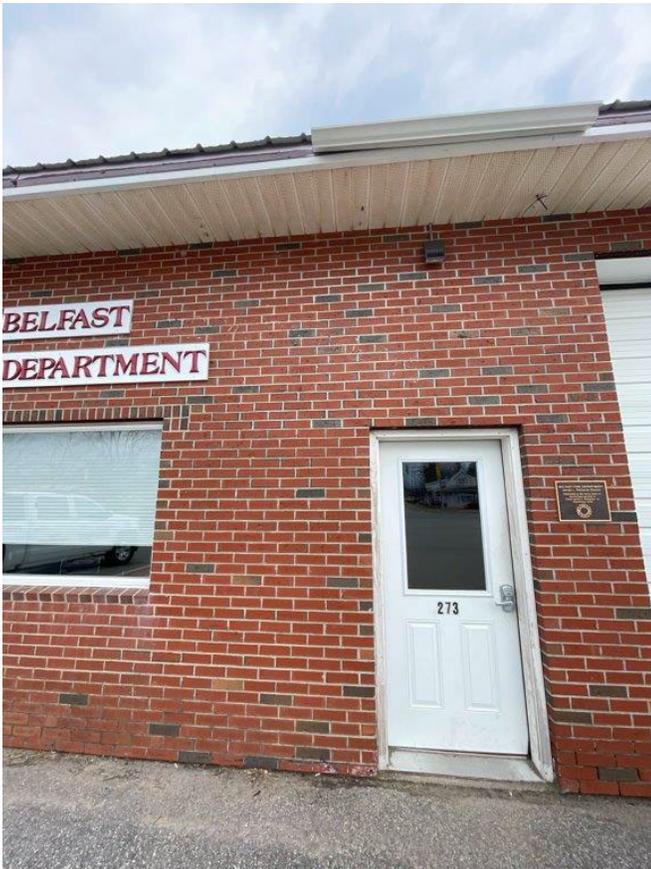
Architectural Photo A11 – Non-Compliant Single Means of Egress

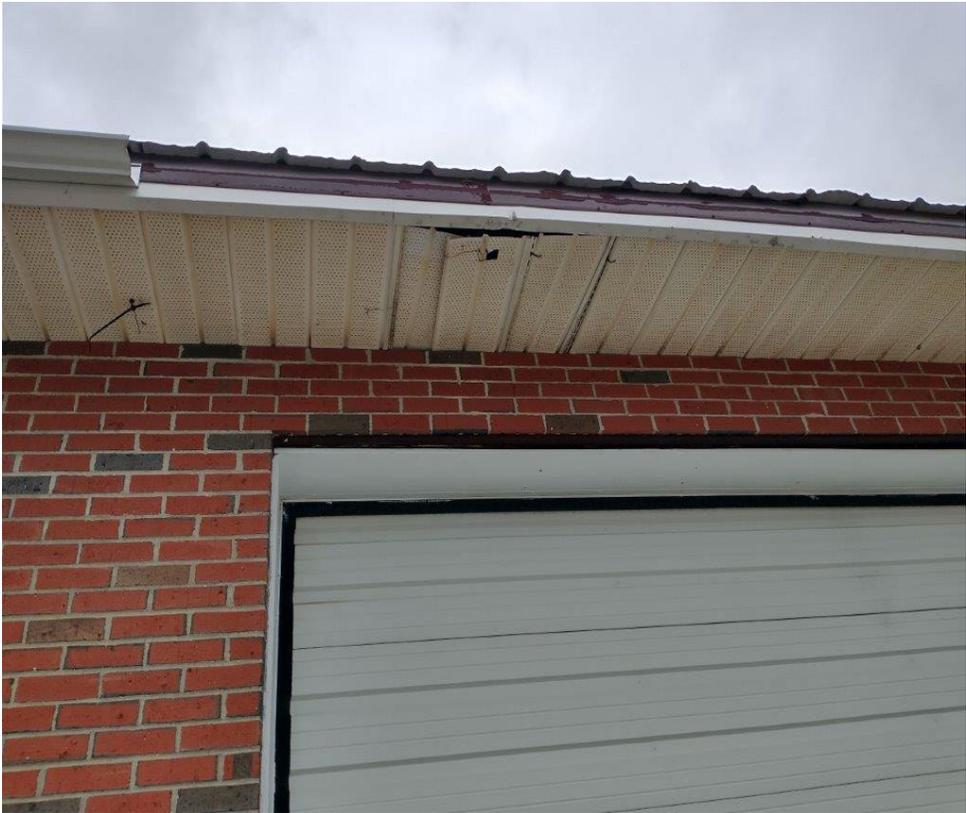
The gabled roof on both the original fire station and the addition is a ribbed metal sheeting with a brown paint finish. The roof on the addition is raised approximately 18 inches higher than the original structure. There are four large solar panel arrays covering most of the south side of the roof. There is a vinyl soffit at the roof overhang perimeter, and the soffit at the south side is damaged (refer to Architectural Photo A12).

Architectural Photo A12 – Exterior Soffit Damage

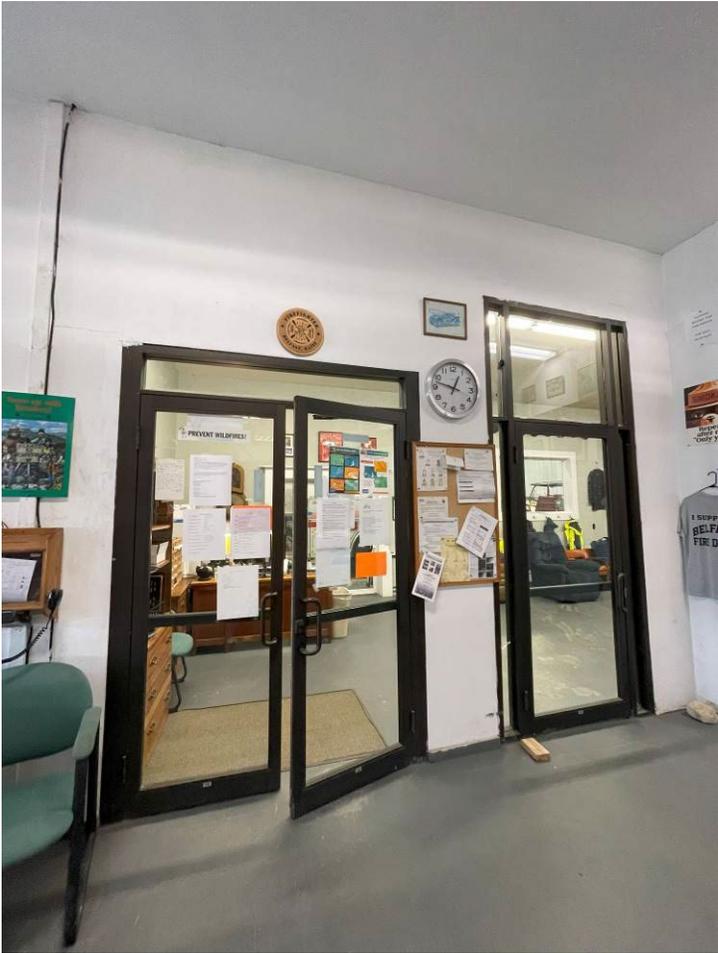
Architectural Photo A15 – Non-Rated Separation at Apparatus Bay

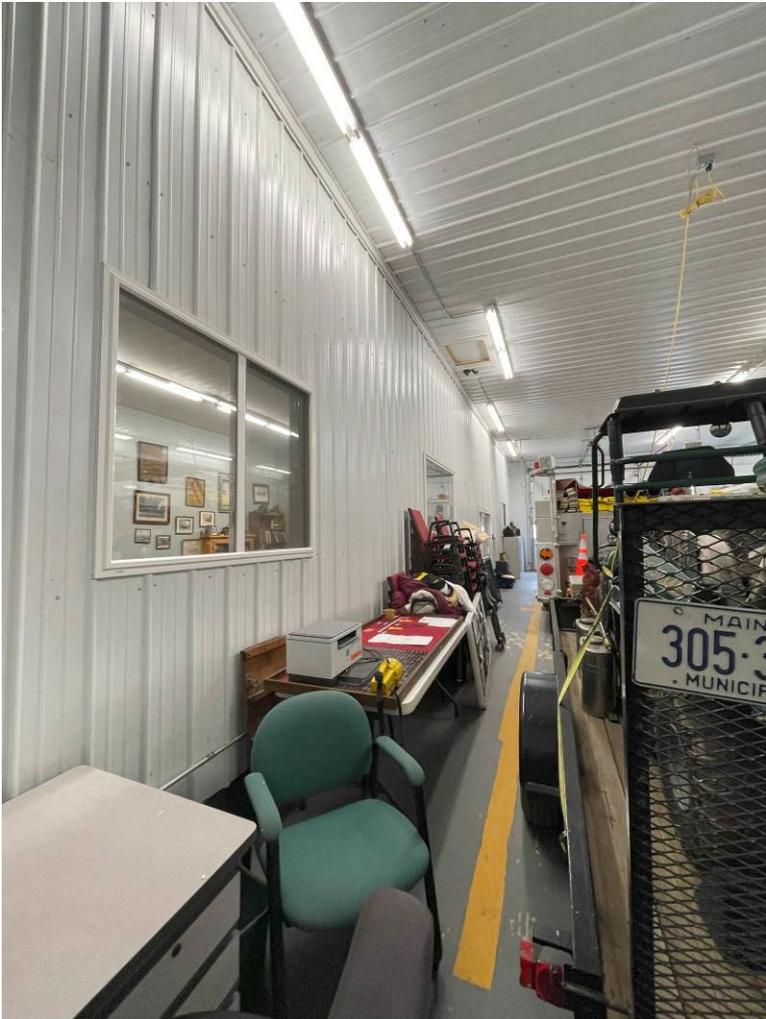
sleeping rooms, typically three firefighters sleep on cots in the day room. There is a storage mezzanine over the bathrooms and kitchen open to the apparatus bays (refer to Architectural Photo A14). The wall separating the apparatus bays and the office/dayroom core are non-fire-rated gypsum board on wood studs with non-fire-rated swinging glass doors and interior windows (refer to Architectural Photo A15). A fire-rated separation wall is required between the office core and the apparatus bays on both sides. The floor in the apparatus bays is a concrete slab. There have been 8-inch wide drainage trenches (refer to Architectural Photo A16), approximately one inch deep, cut to help direct water to a trench drain running east west up the middle of the bays. The trenches were cut after construction of the building and are a tripping hazard. The walls and ceiling in the original building are painted gypsum board. The addition has two vehicle bays with narrower sectional doors. The walls and ceiling in the addition have a painted metal liner panel (refer to Architectural Photo A17).

Architectural Photo A17 – Non-Rated Separation at Apparatus Bay Addition

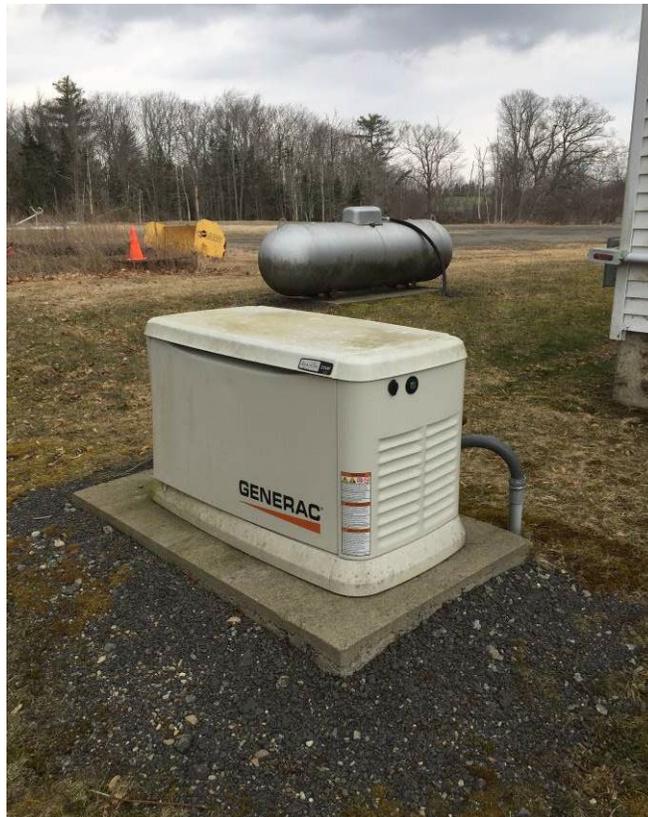
The building is also supplied by a Generac generator located to the west of the building to provide power during a utility power outage (refer to Electrical Photo E2). The generator appears to feed the entire building and also appears to be a backup generator and not an emergency generator.

Electrical Photo E2 – Generator
