CITY OF BELFAST

MANAGER'S REPORT
Belfast City Council Meeting
Tuesday, December 16, 2025

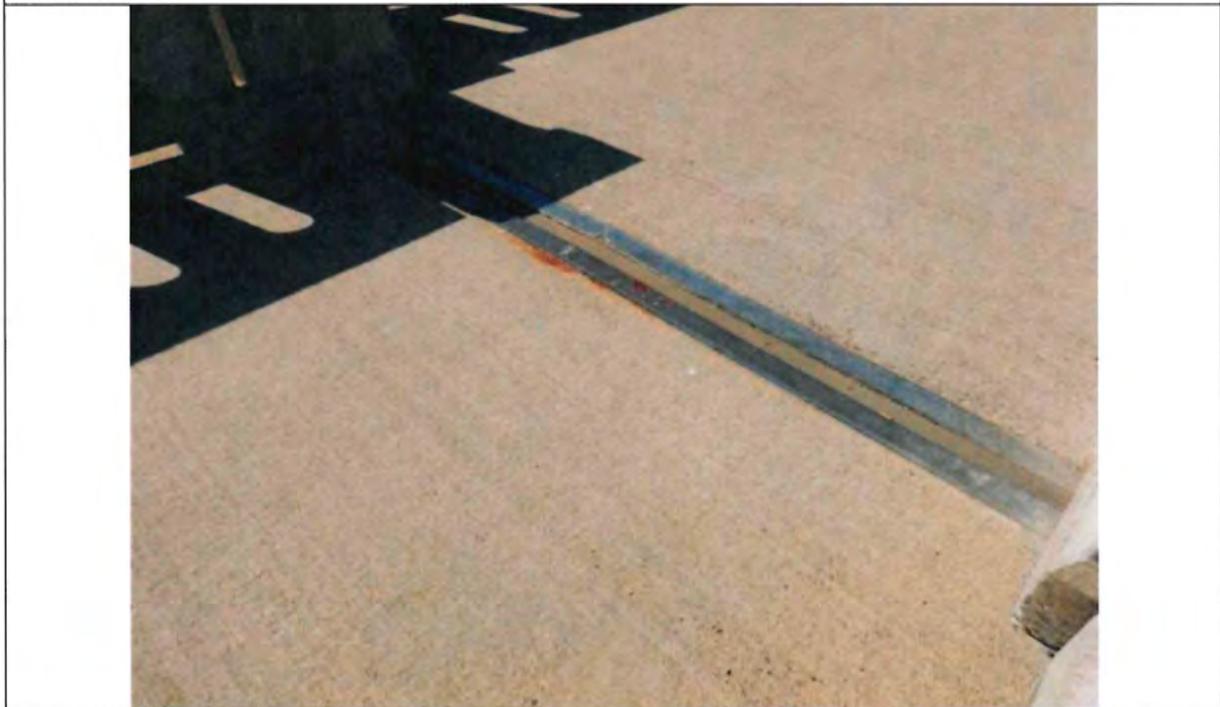
Photo No. 7 - 0124

Description: Condition of deck in Span 1.

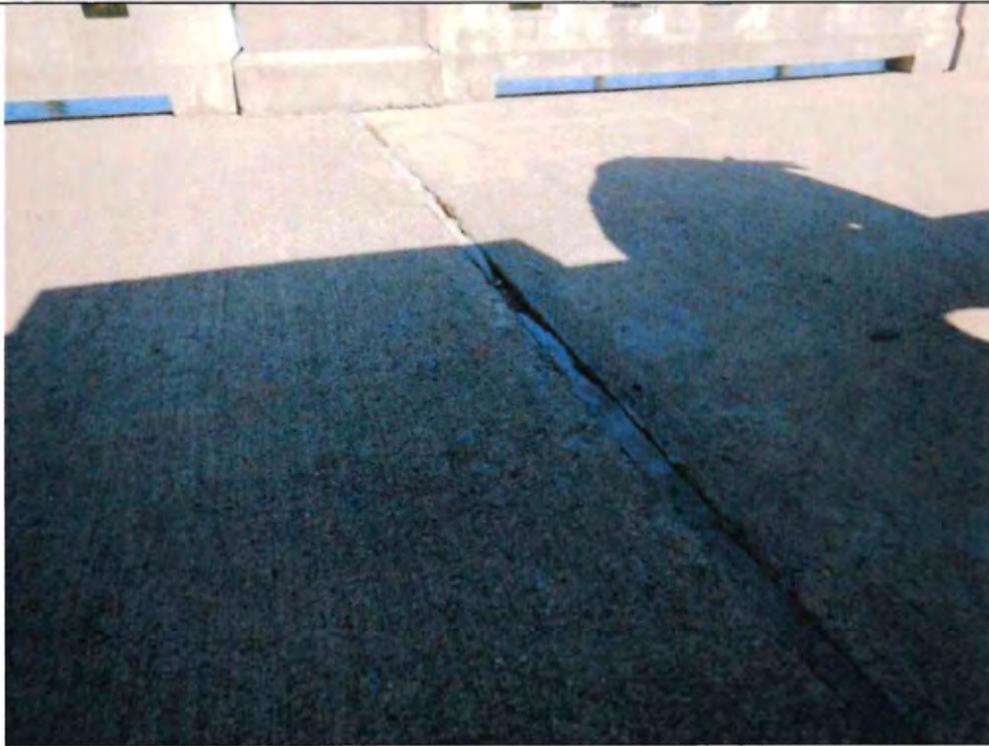
Photo No. 8 - 0067

Description: Typical condition of neoprene expansion joint with impact damage, tears, and debris accumulation. Pier 4 joint shown, other expansion joints similar.

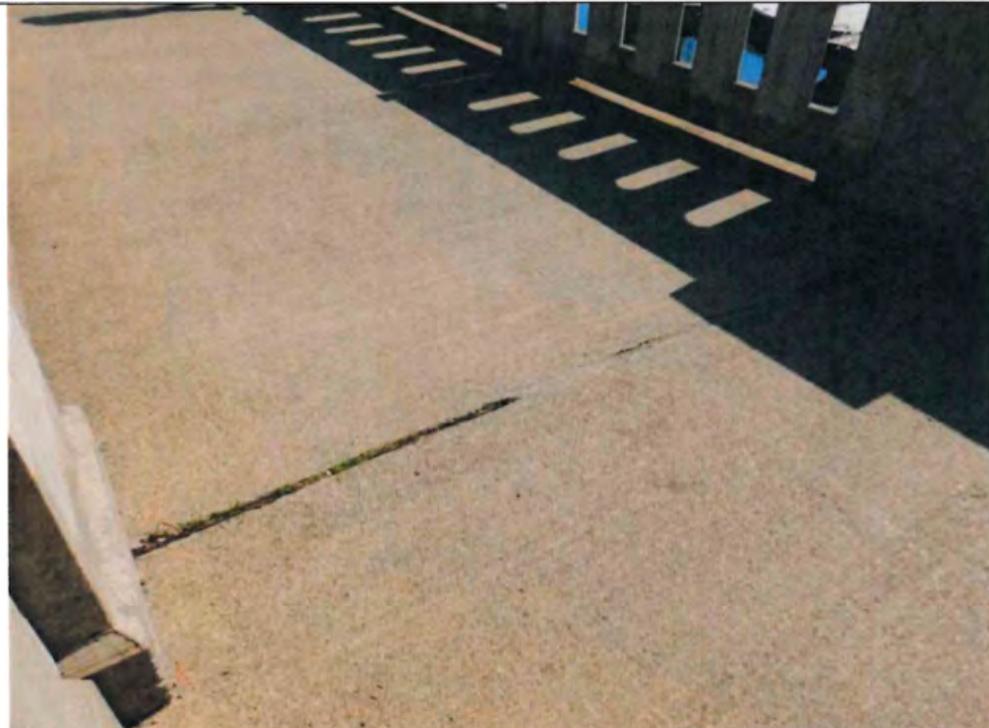
Photo No. 9 - 0059

Description: Typical condition of the silicone fixed joint with depression of the seal and debris accumulation. Pier 5 joint shown, other fixed joints similar.

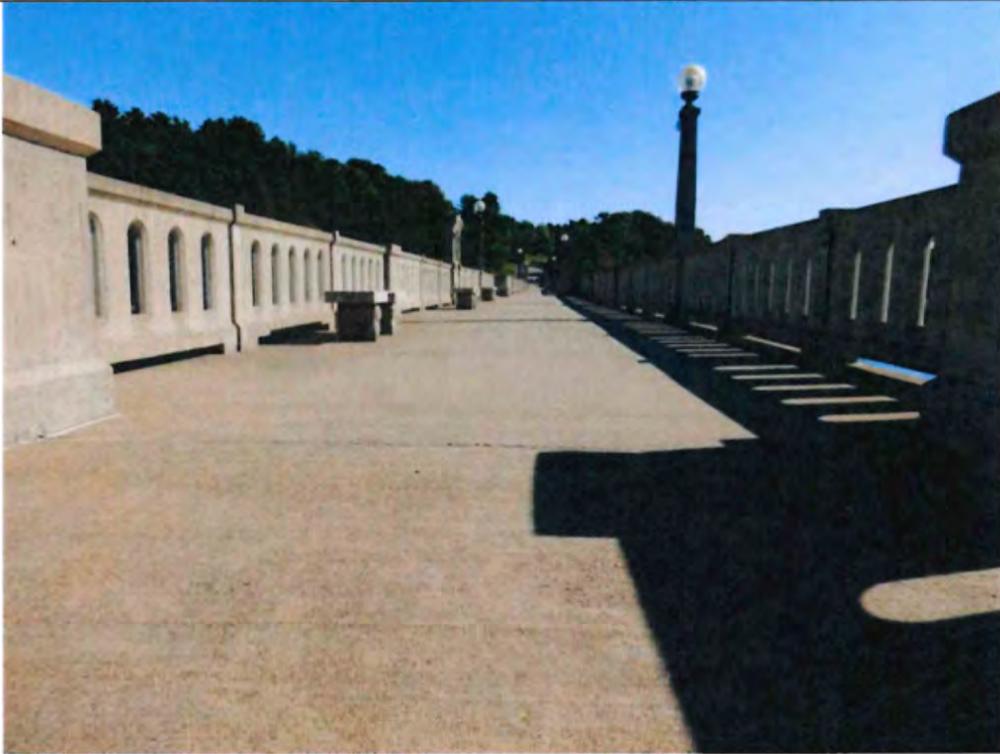
Photo No. 10 - 0108

Description: Fixed joint seal pushed out up to a third of the joint length at Pier 1.

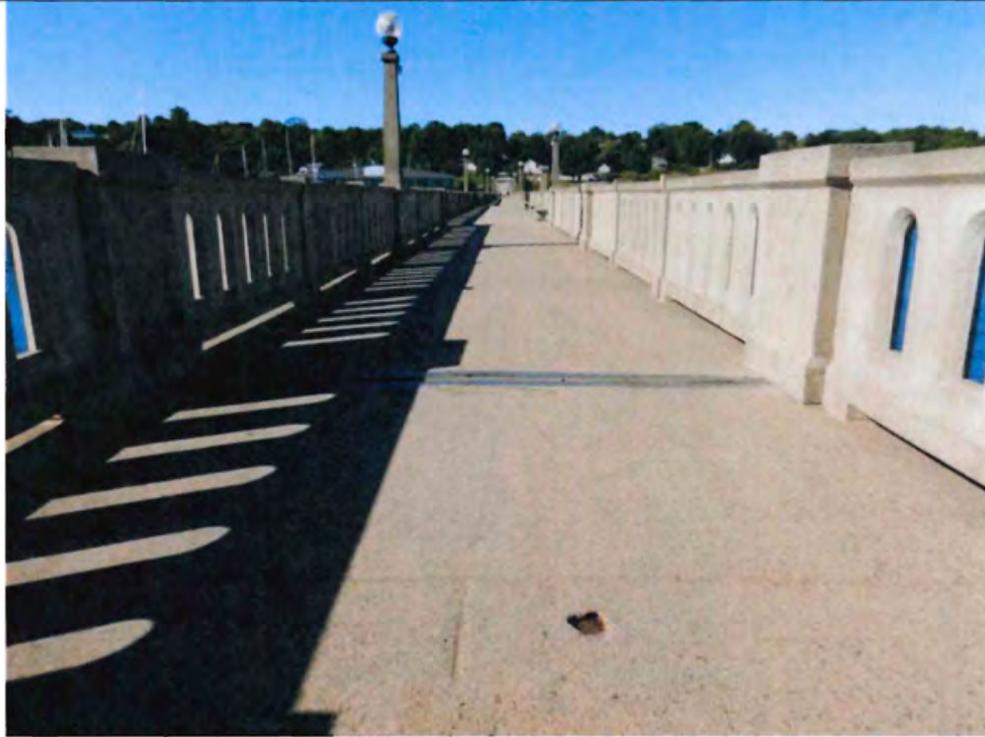
Photo No. 12 - 0029

Description: Deck spall up to 3'-1" long and longitudinal crack along the north rail in Span 9.

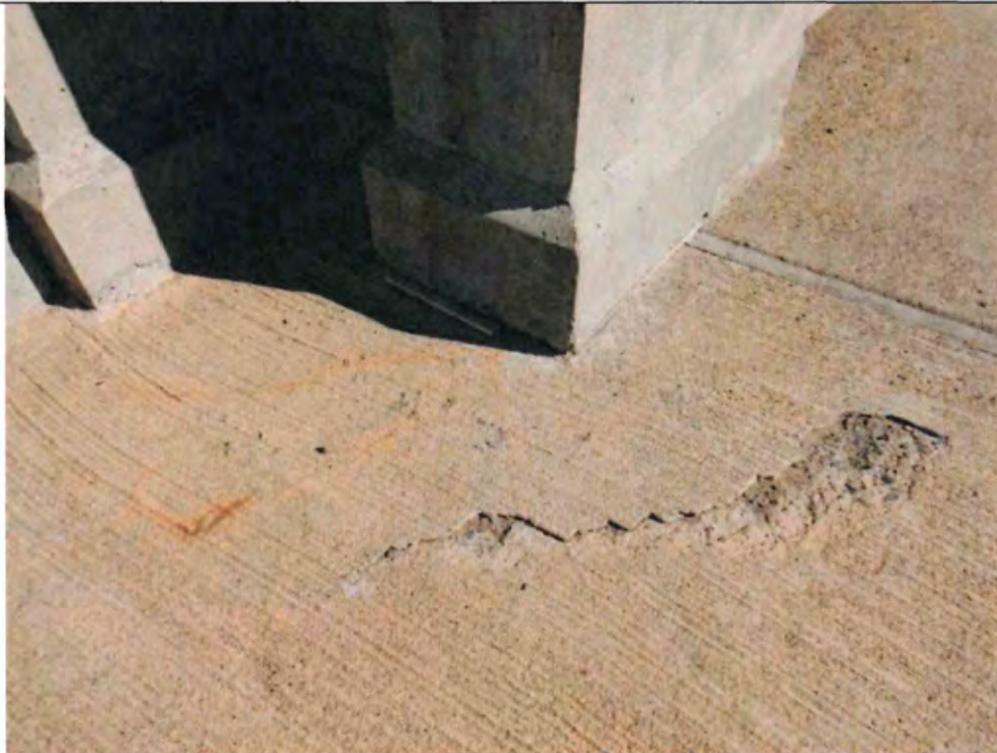
Photo No. 13 - 9912

Description: 3" popout in deck surface, transverse crack, and trowel lines in Span 16.

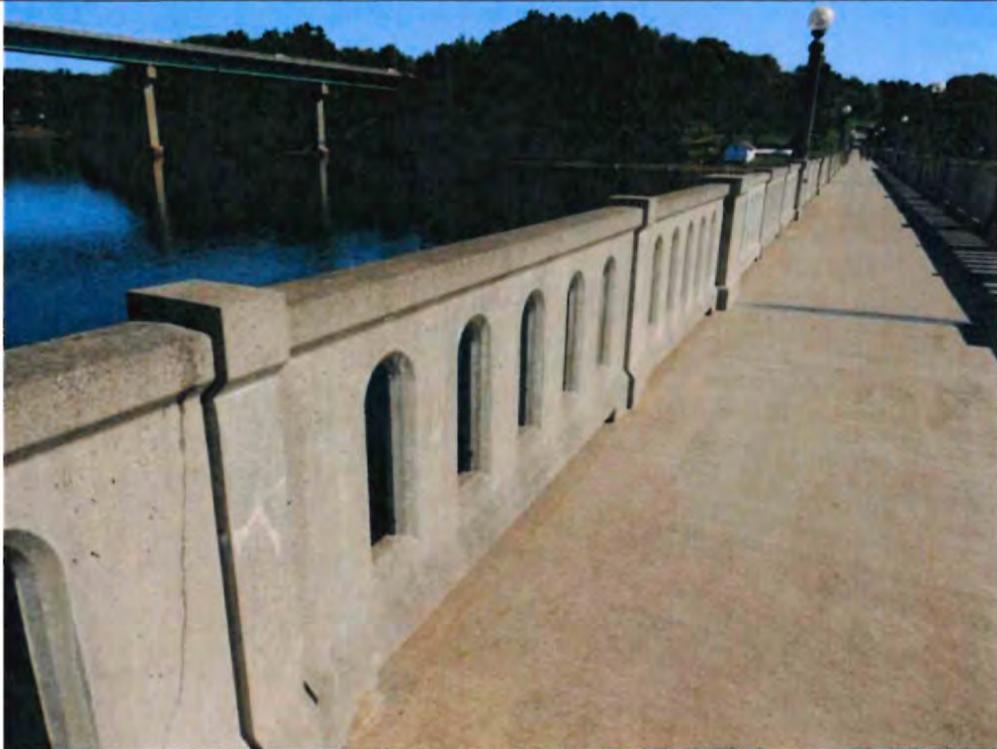
Photo No. 14 - 9941

Description: Spall up to 2'-4" long and exposed PTFE up to 1" wide on the north side of Span 14.

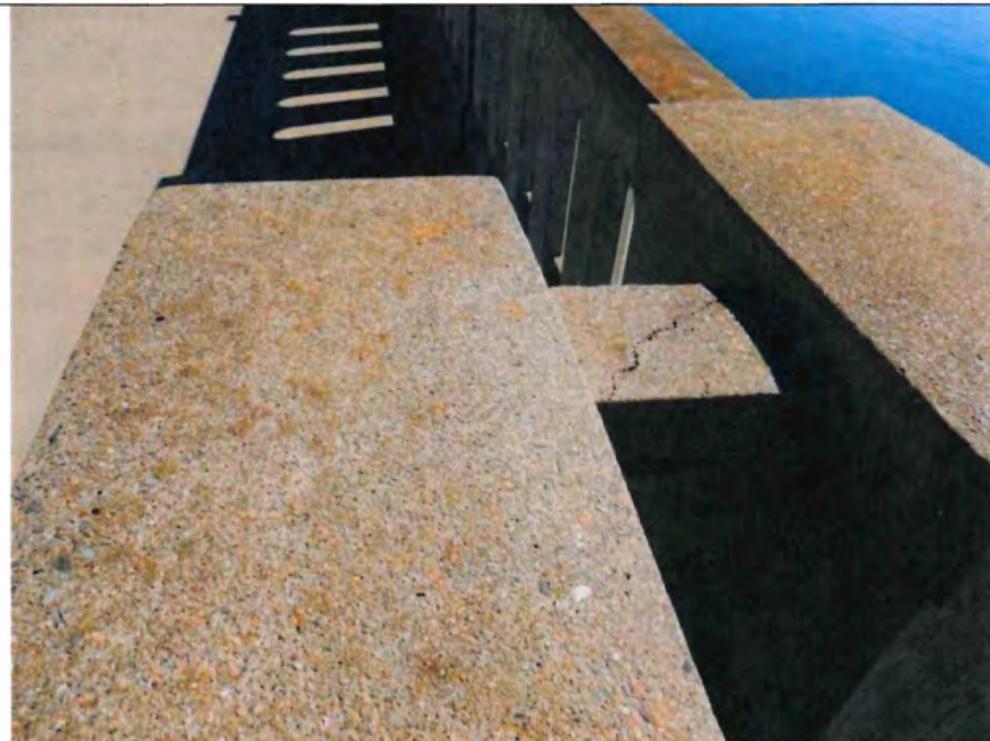
Photo No. 15 - 0020

Description: Typical condition of concrete bridge rail. Note scattered efflorescence, minor cracking, and water staining. Span 9 shown.

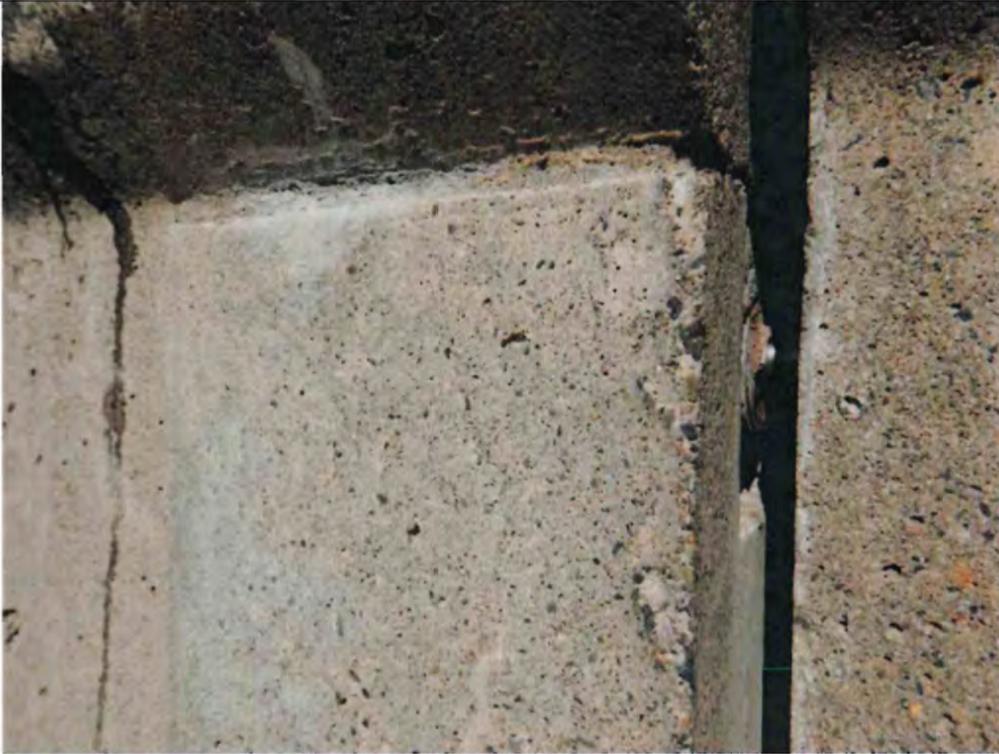
Photo No. 16 - 9971

Description: Full-width crack in the bridge rail top cap in the south rail of Span 12.

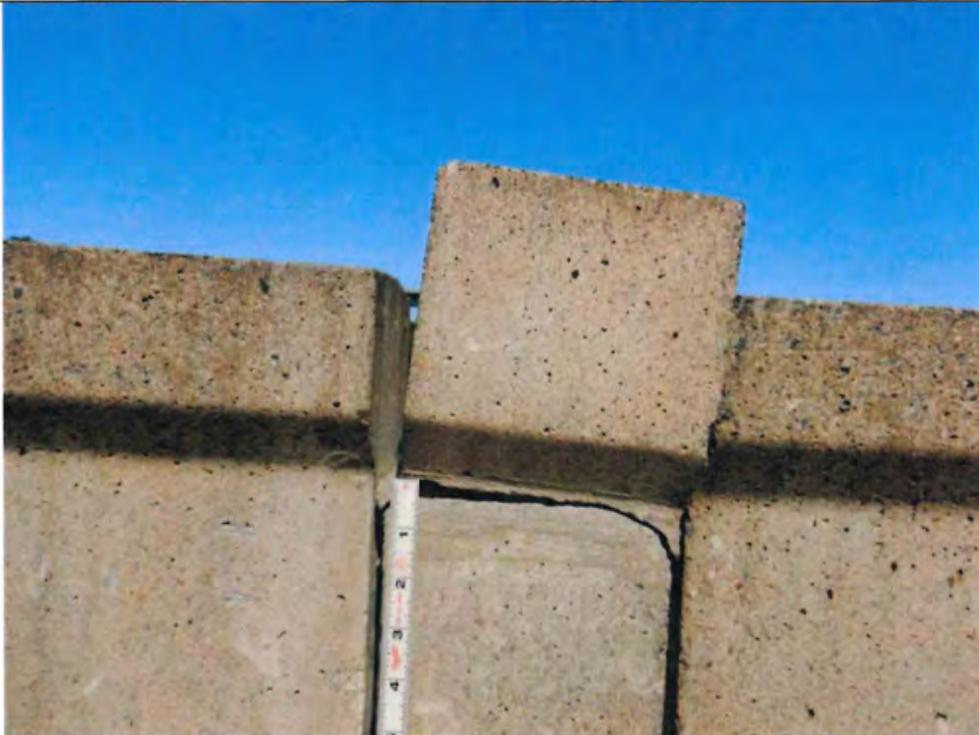
Photo No. 17 - 0023

Description: Typical missing grout in intermediate rail post blackout. Span 9 north rail post shown, others similar.

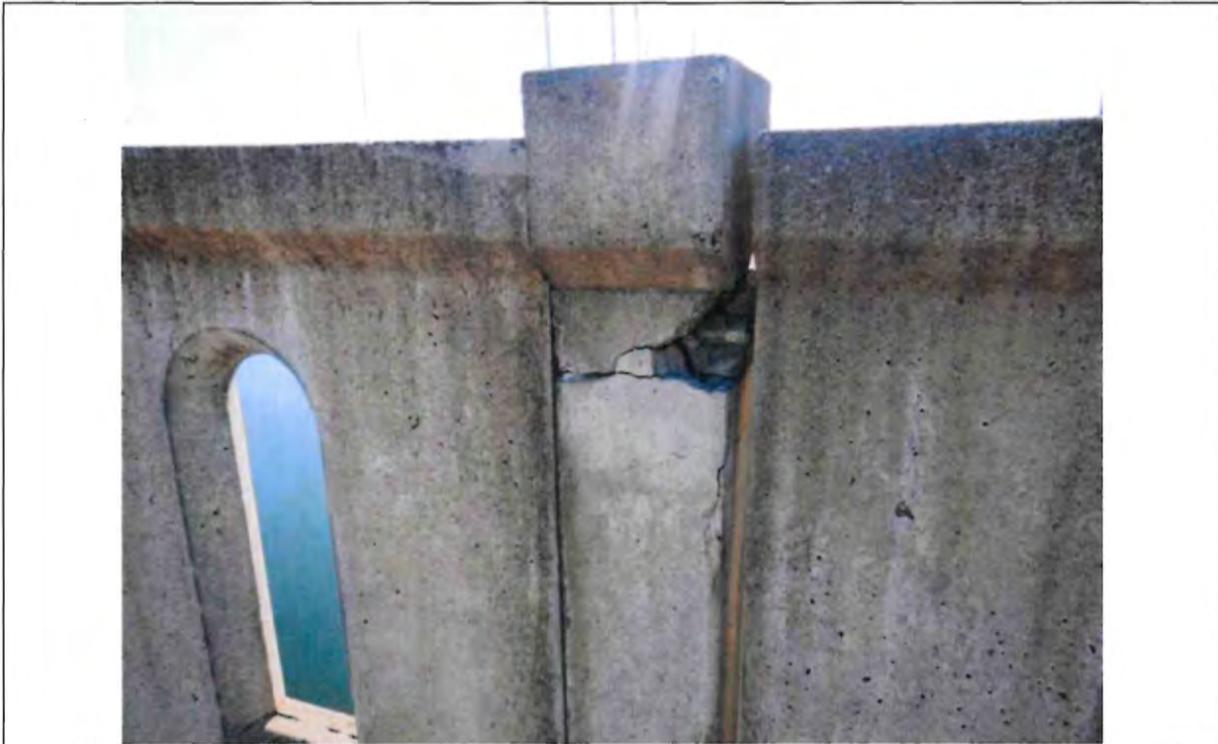
Photo No. 18 - 0102

Description: Full-width crack between intermediate post cap and stem, up to 1/4" wide. Span 2 north rail post shown.

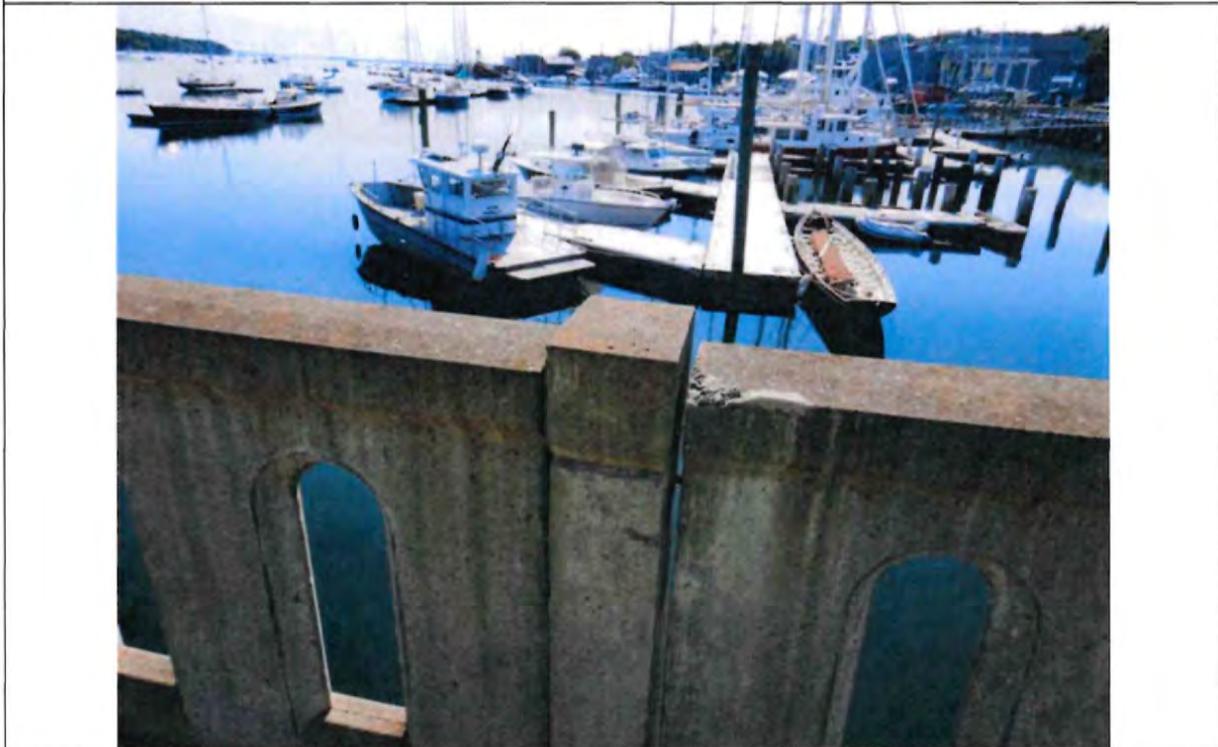
Photo No. 19 - 0115

Description: Span 1 south intermediate post with cracks, spalls, and visible reinforcing.

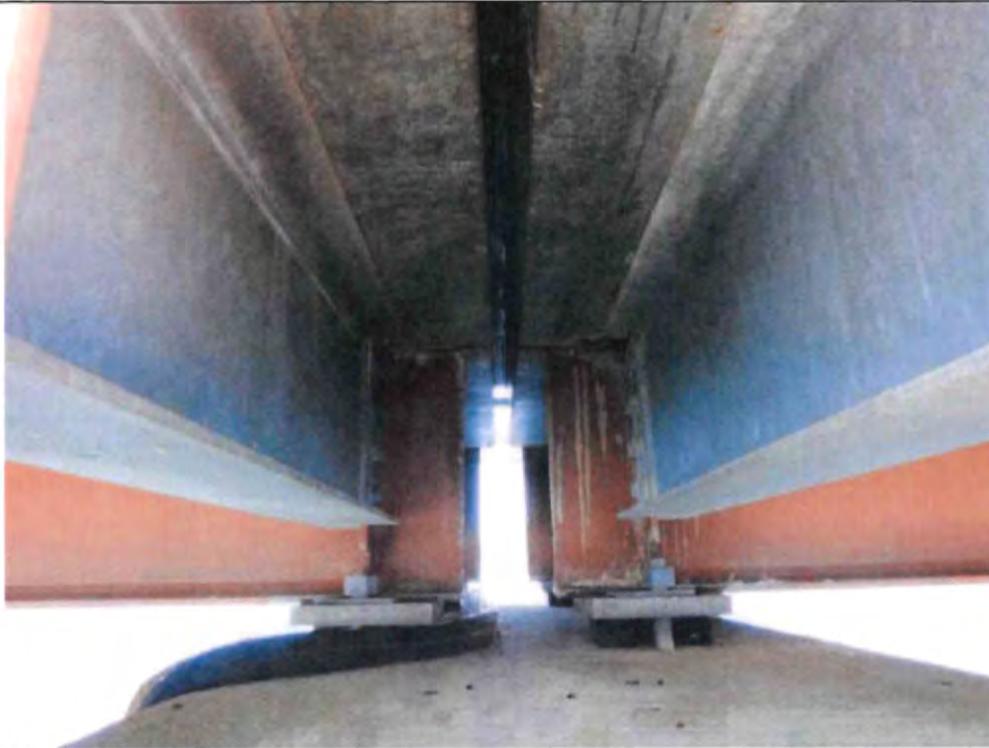
Photo No. 30 - 0219

Description: Failed backer rod causing corrosion and rust staining at the end diaphragm of Span 6 over Pier 5.

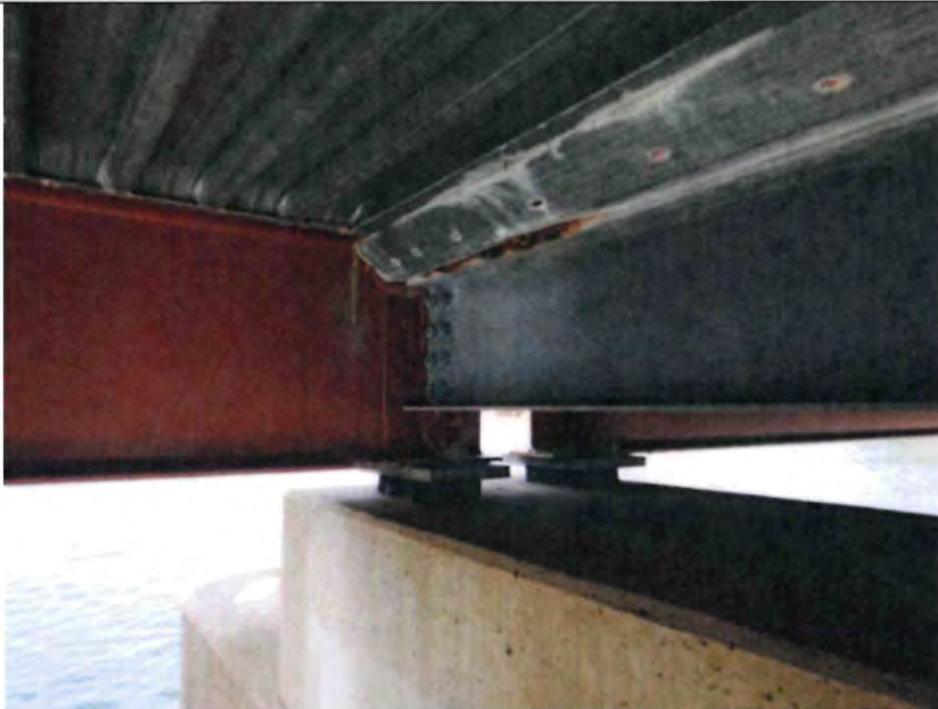
Photo No. 32 - 0169

Description: Corrosion on the diaphragm connection plate to bottom flange weld. Span 15 south beam shown, others similar.

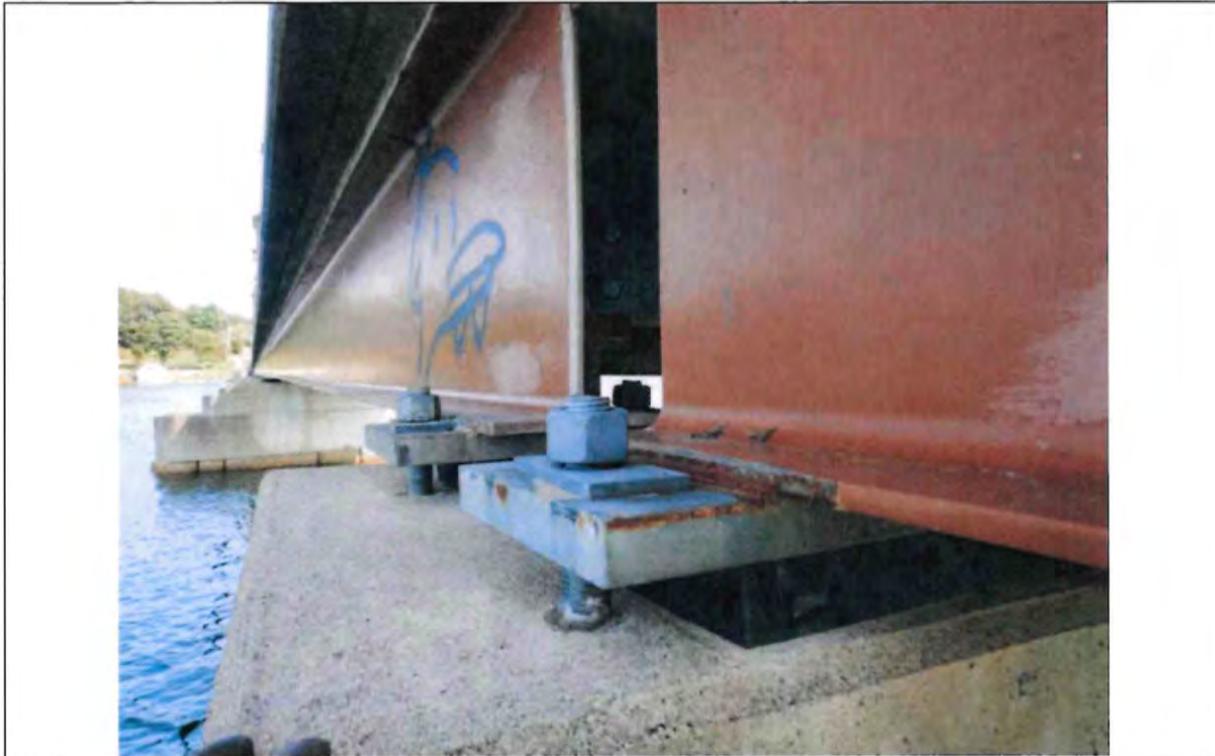
Photo No. 34 - 0215

Description: Up to 1/4" wide by 1/4" deep split in elastomer in south beam at Pier 6.

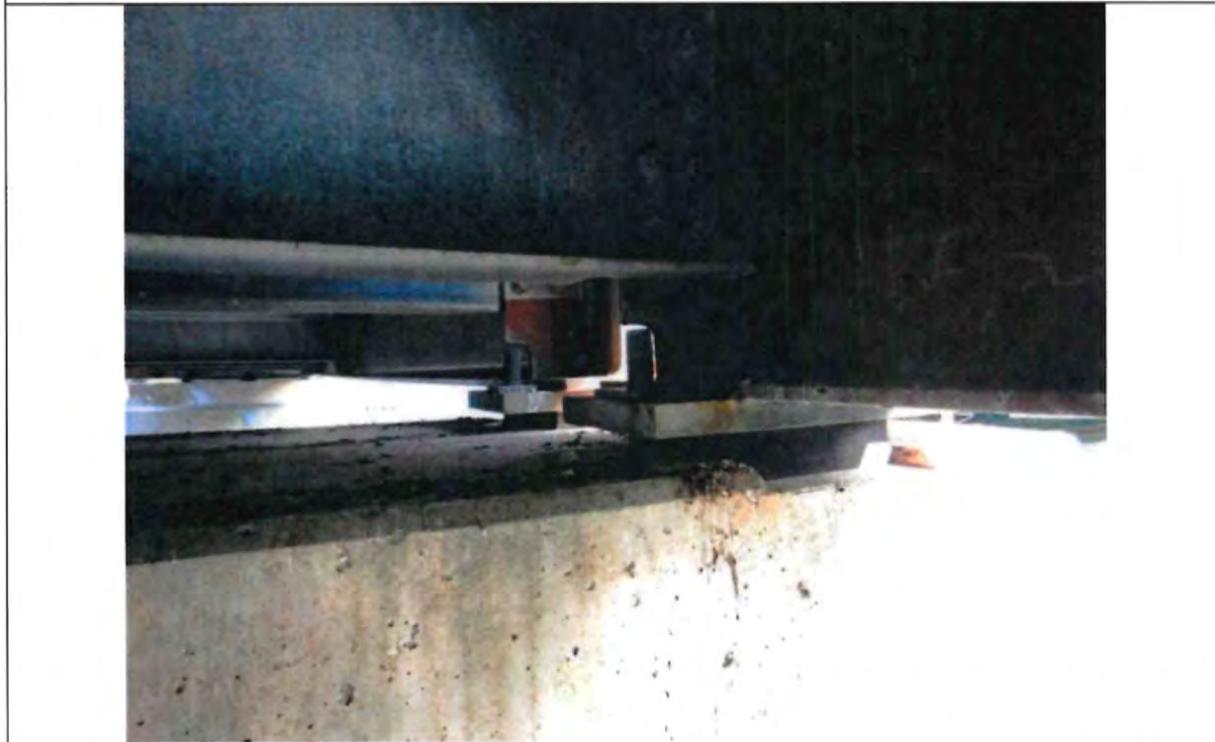
Photo No. 35 - 0218

Description: Corrosion on Span 7 north beam to sole plate weld due to removal of paint during construction. Other welds similar.

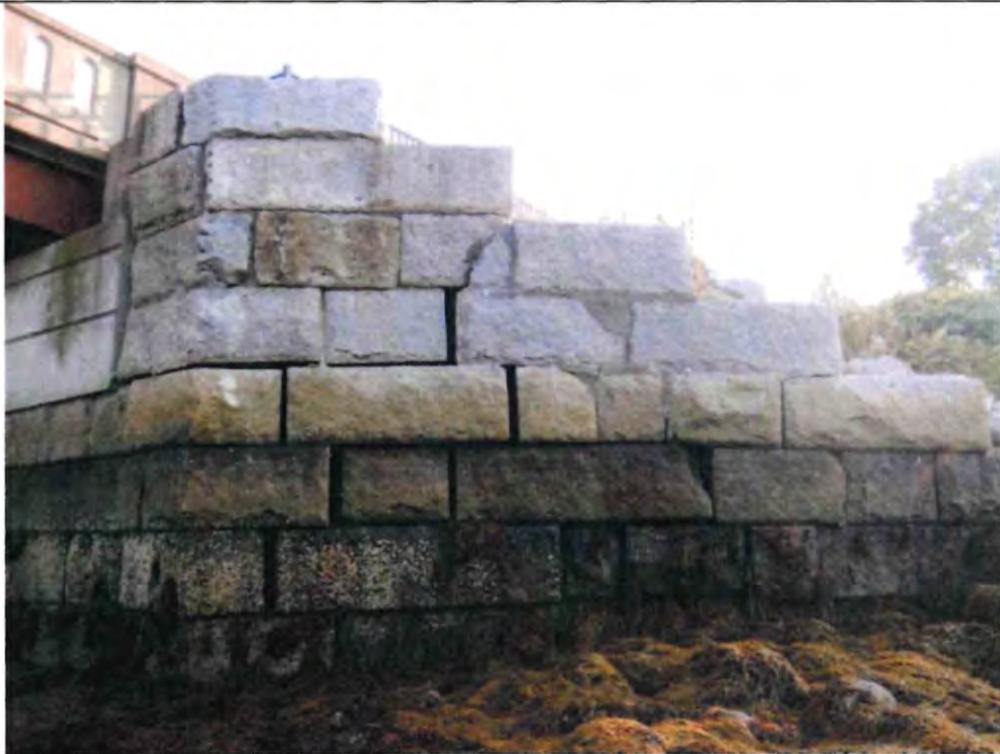
Photo No. 37 - 0281

Description: East elevation of Abutment 1 with missing mortar below the water line and shifted stones.

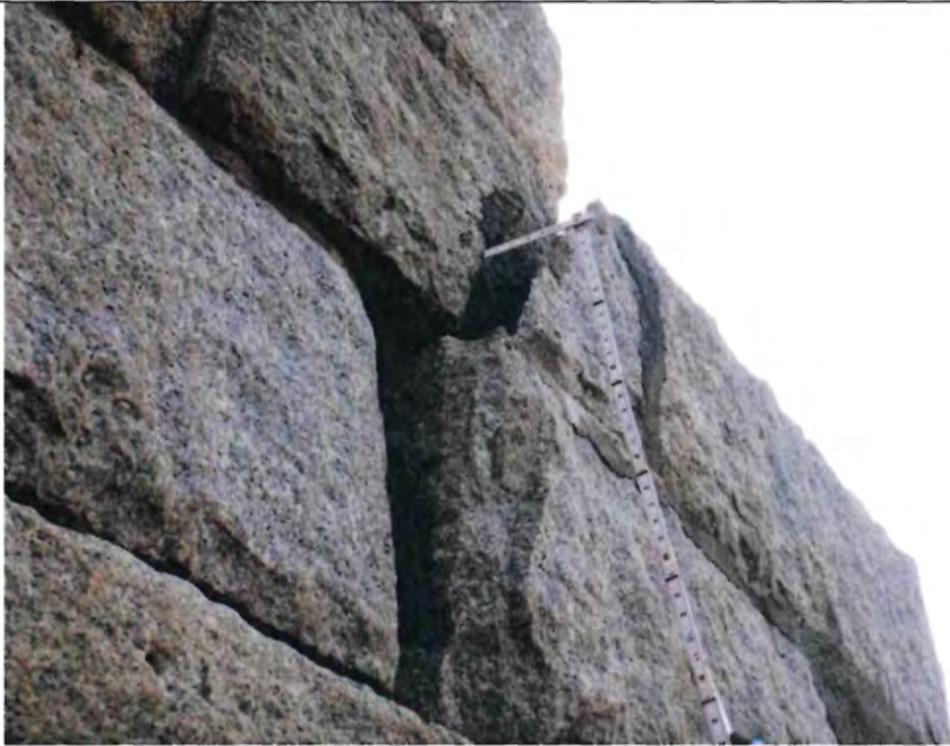
Photo No. 38 - 0290

Description: General condition of the north wingwall at Abutment 1 with missing mortar and shifted stones.

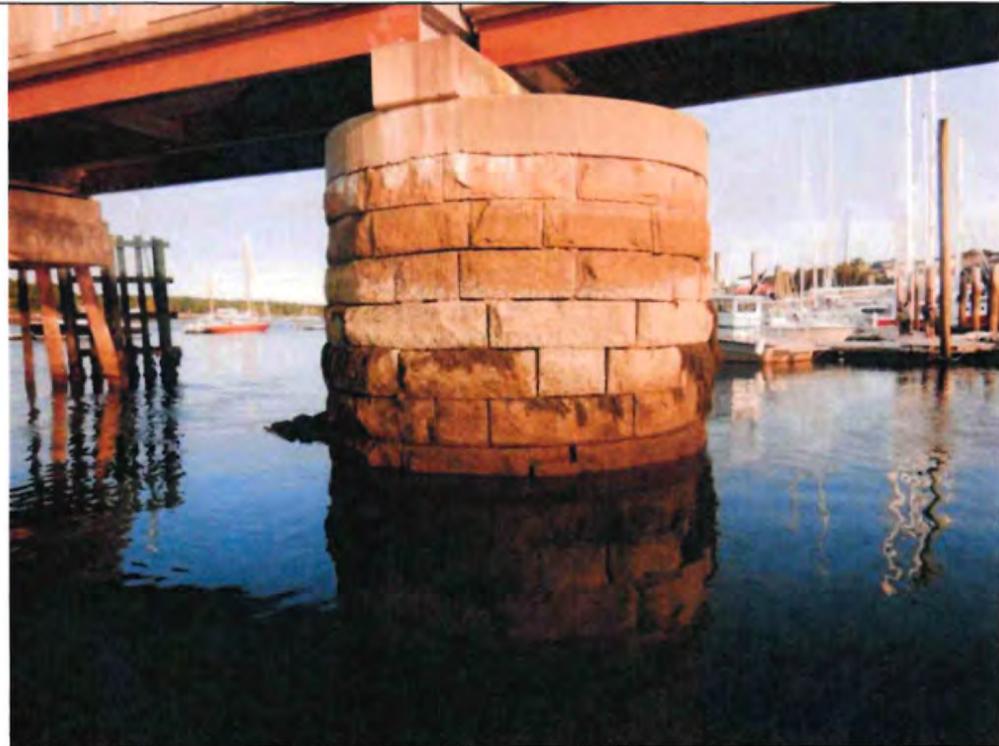
Photo No. 41 - 0301

Description: North elevation of Pier 1, others similar. Concrete cap is misaligned up to 6".

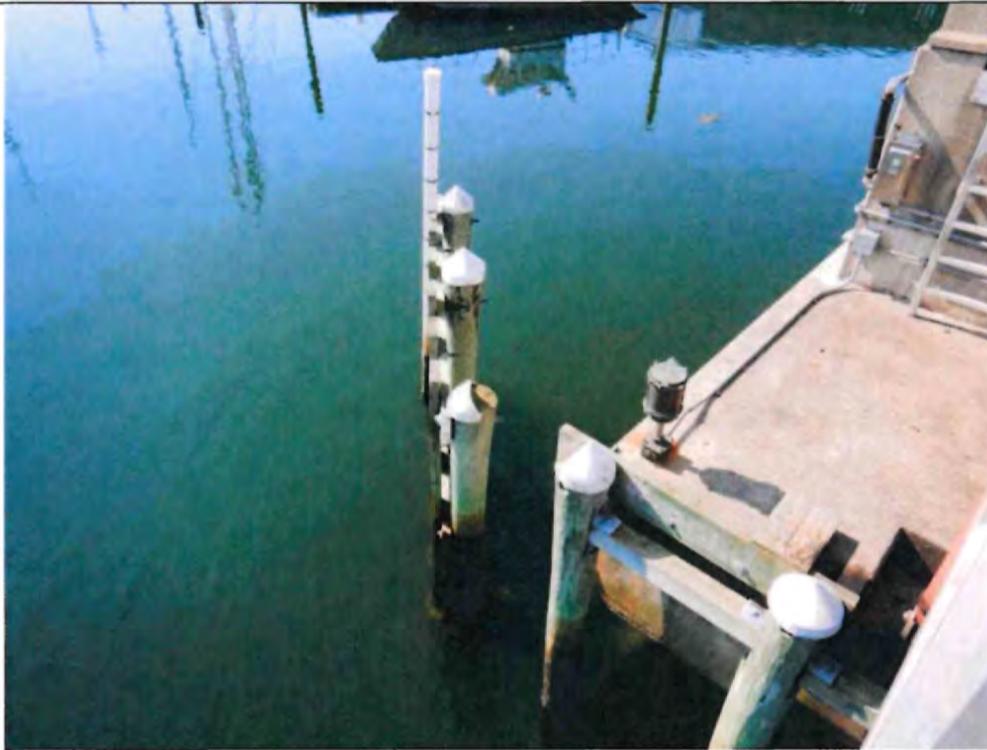
Photo No. 42 - 0325

Description: Northwest elevation of Pier 2. Note typical missing mortar below waterline.

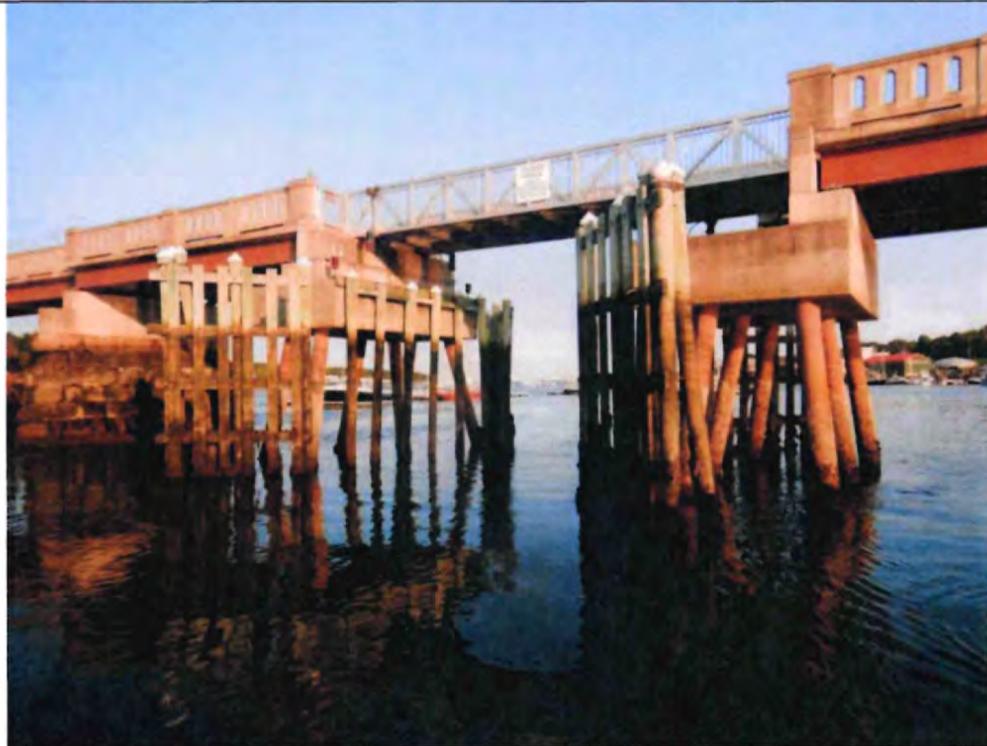
Photo No. 43 – 0080

Description: Typical condition of timber fender system. SW fender shown, others similar. Note two broken pile caps.

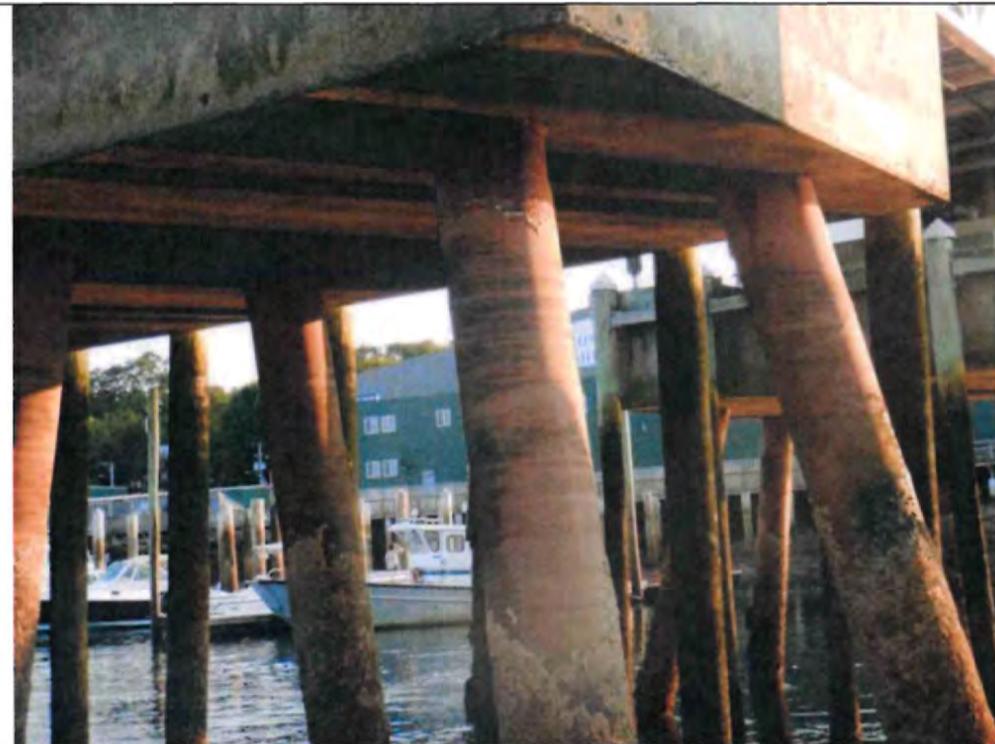
Photo No. 45 – 0340

Description: Scattered epoxy coating failures on steel pipe piles below Pier 3A.

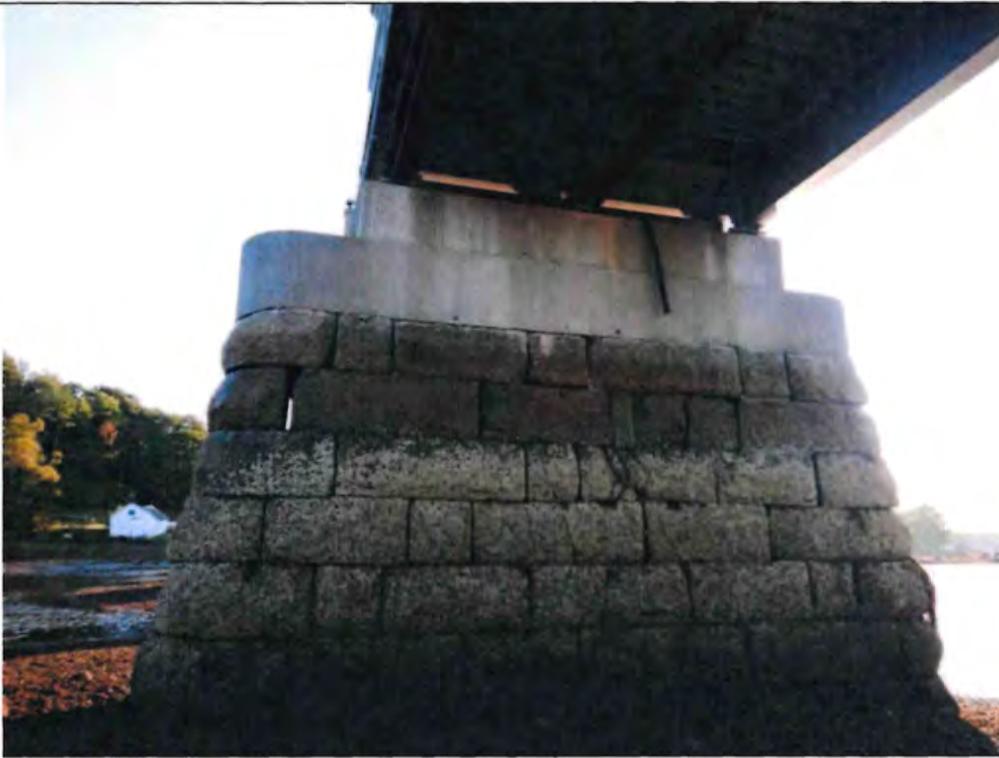
Photo No. 46 - 0360

Description: Scattered epoxy coating failures on steel pipe piles below Pier 3B.

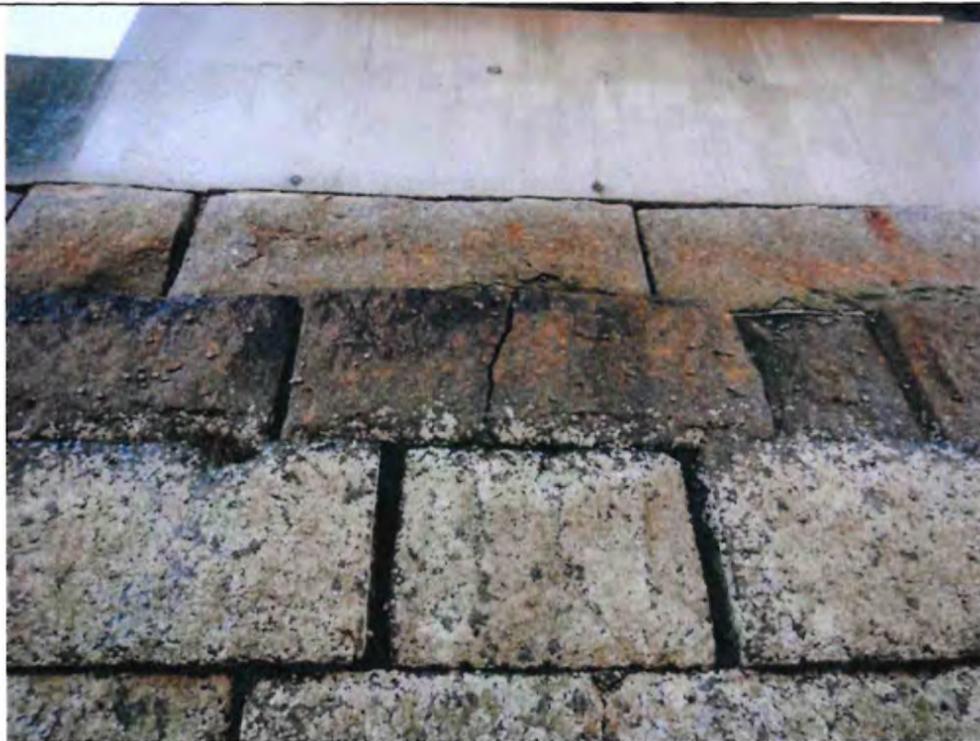
Photo No. 47 - 9695

Description: West elevation of Pier 12. Note previously replaced neoprene joint seal and daylight highlighting missing mortar.

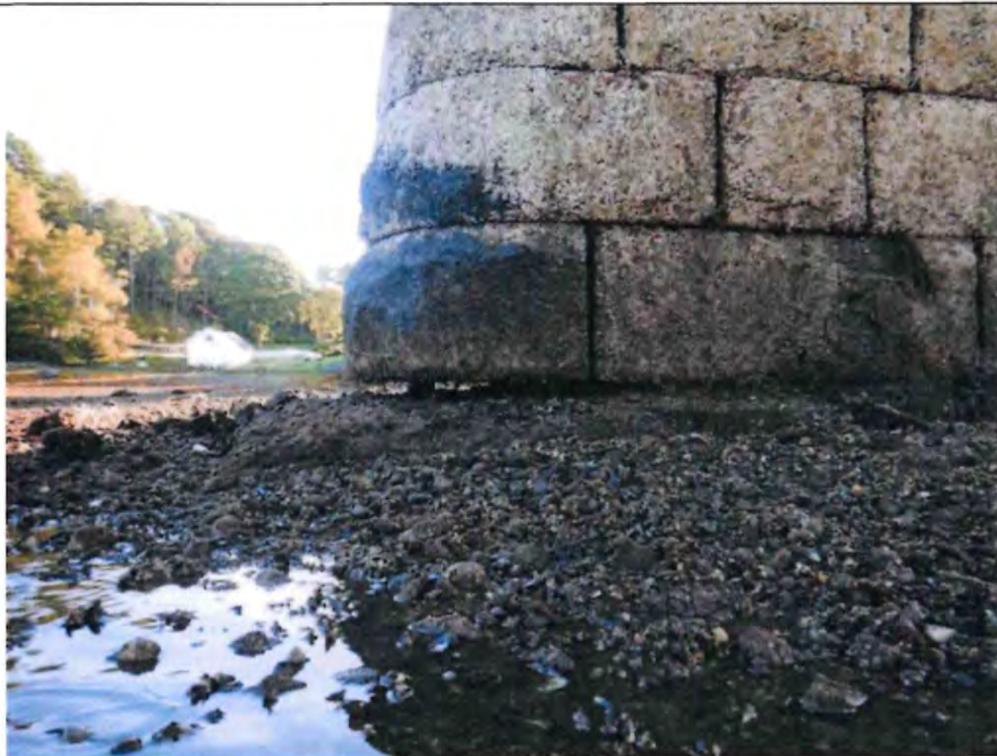
Photo No. 48 - 9724

Description: Full height crack up to 1" wide in the 2nd course block on the west face of Pier 13.

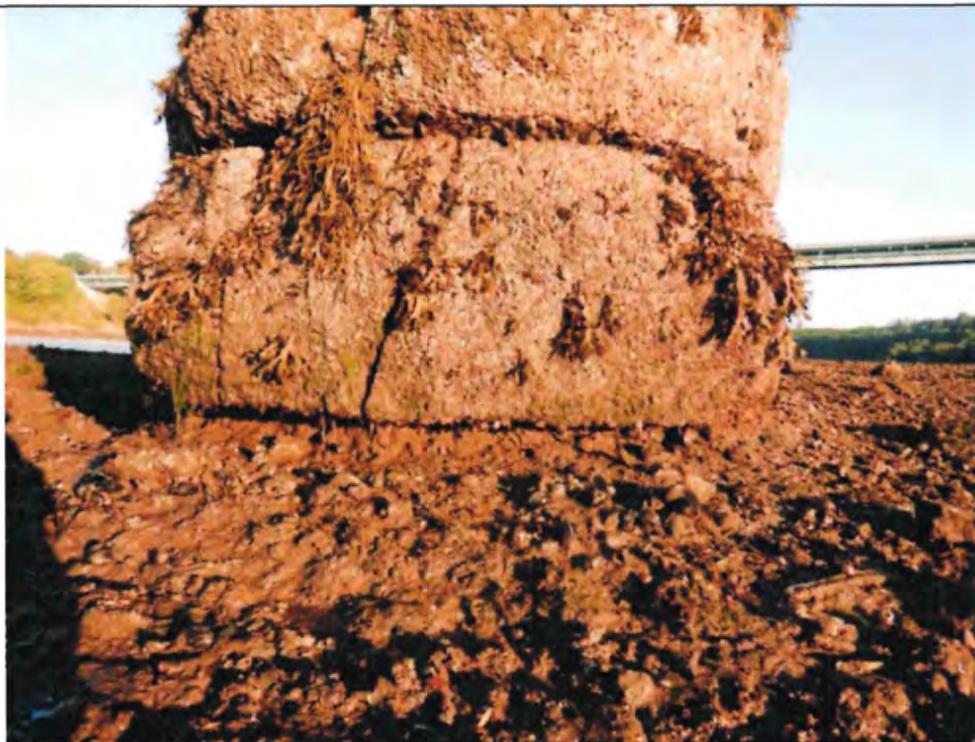
Photo No. 49 - 9729

Description: Undermining up to 2'-10" deep at the North face of Pier 13.

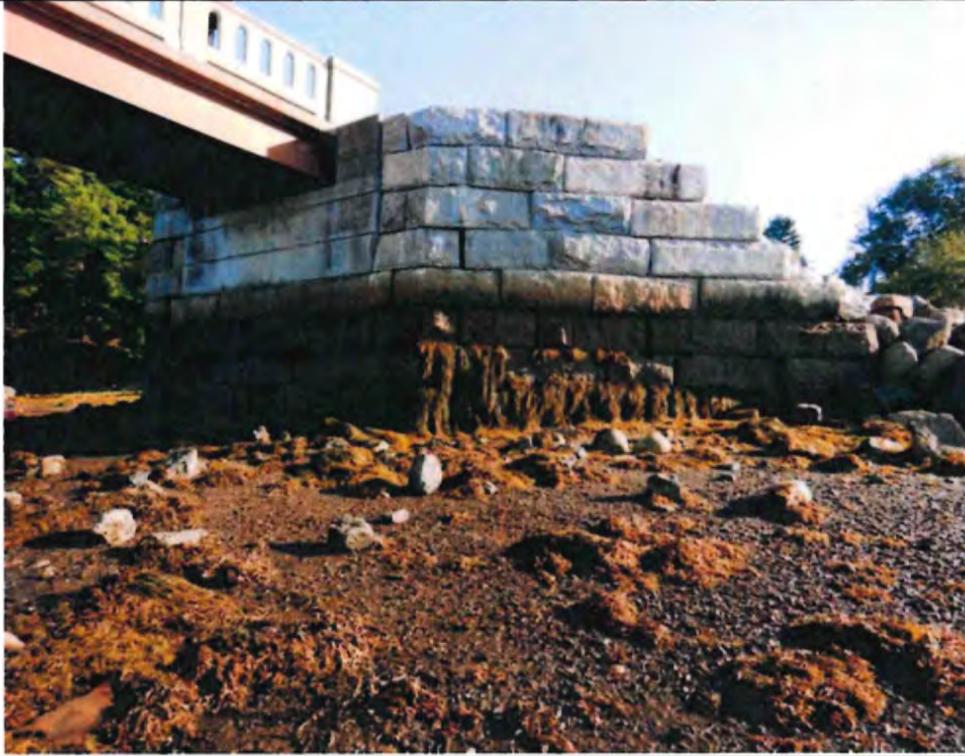
Photo No. 50 - 9660

Description: Full-height crack at the bottom course and undermining up to 14" deep on the south face of Pier 9.

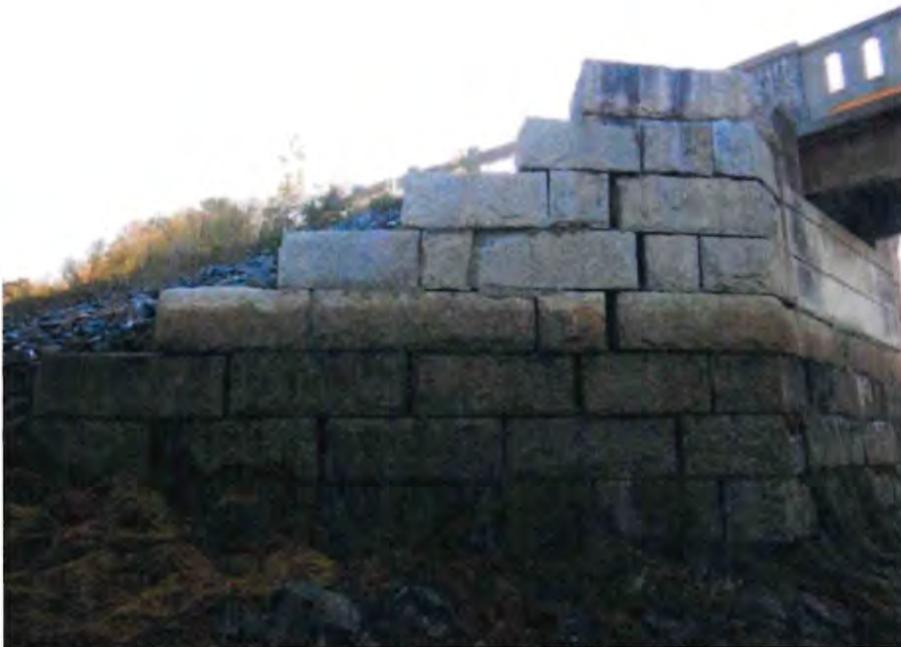
Photo No. 51 - 9838

Description: South elevation of Abutment 2 with shifted stones.

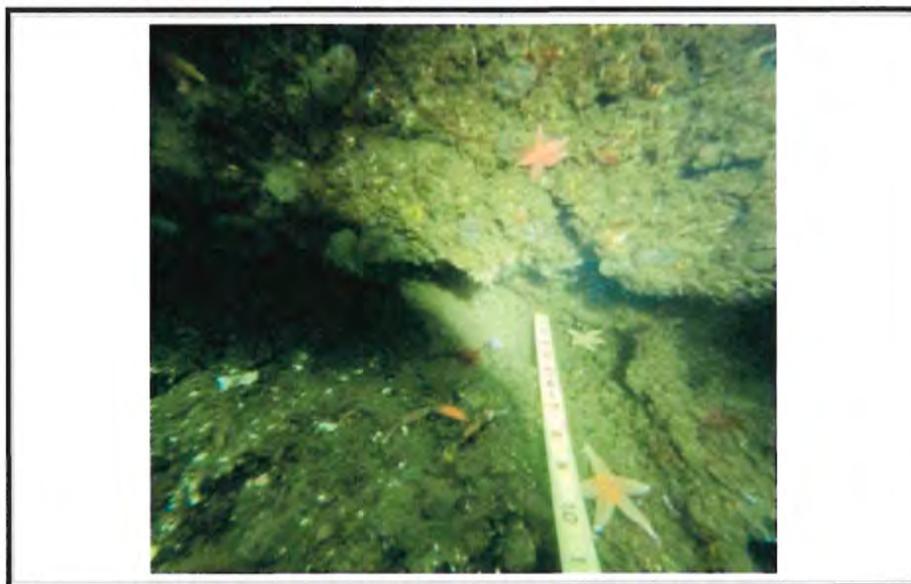
Photo 009

Pier 2: Void between stone course and concrete foundation

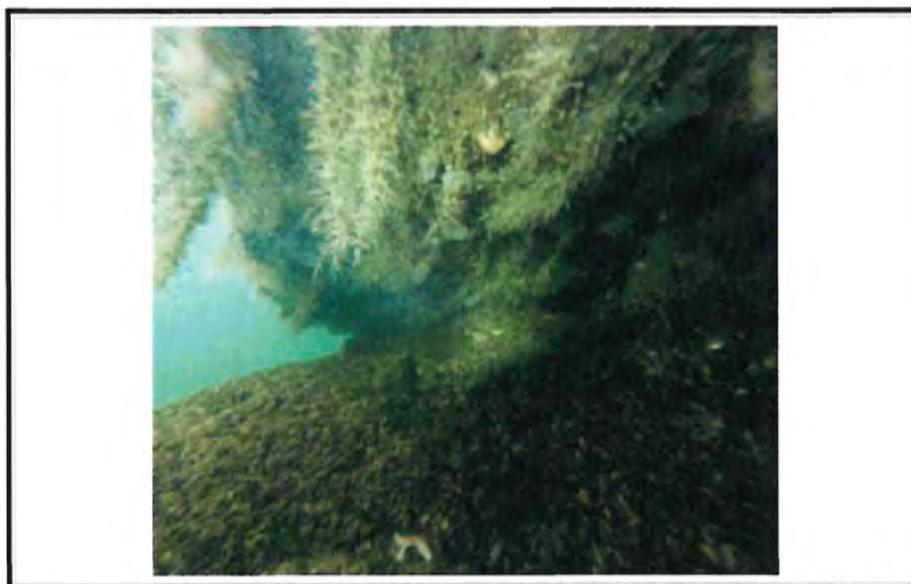
Photo 010

Pier 4: Void between stone course and concrete foundation
