CITY OF BELFAST

MANAGER'S REPORT
Belfast City Council Meeting
Tuesday, December 16, 2025

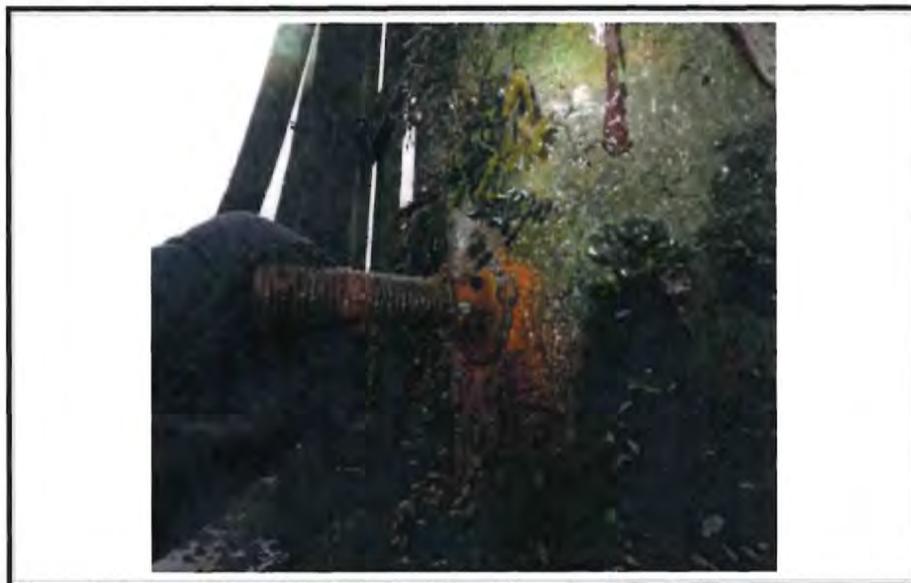
Photo 015

Fender system: Corroded washer

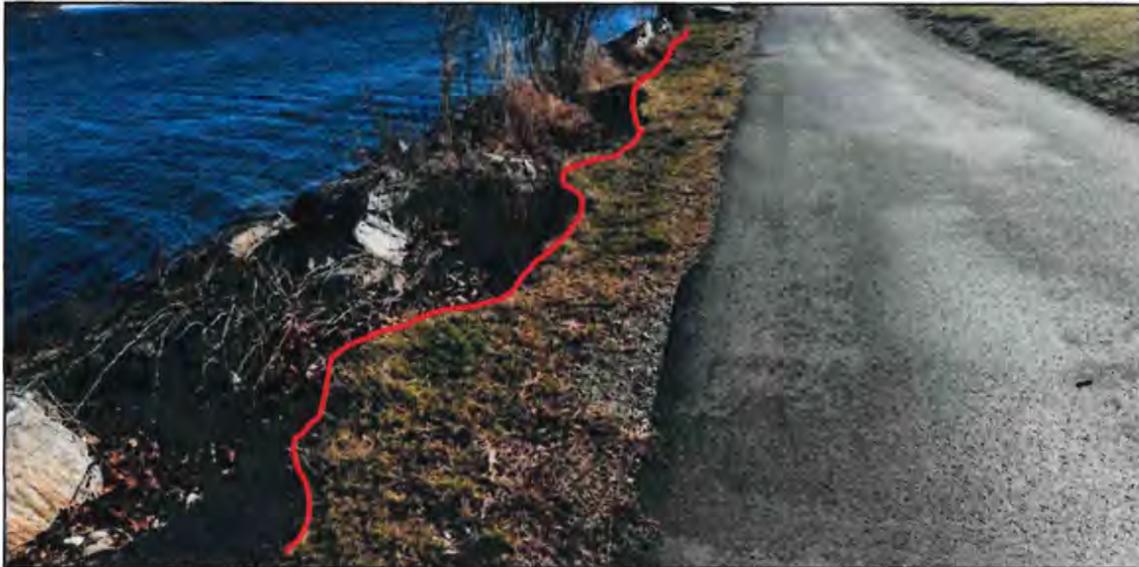
Figure 4-17. Example of erosion along Harborwalk (North). Red area highlights top of bank erosion.

A near-term recommendation to address this is to repair and elevate the height of the shoreline stabilization. This could be achieved with a hybrid shoreline stabilization system that uses larger toe stones, with coir mat or logs, and native plantings in place of only utilizing riprap. A concept showing this approach is included in Figure 4-18. This would require the path and park area also be elevated and a concept design for this is shown in Appendix B. If the City moves forward with elevating the Harborwalk, consideration should be given to addressing stormwater management. This can include the installation of storm drains and outfall pipes that daylight within the riprap as included in this concept design plan.
