CITY OF BELFAST

MANAGER'S REPORT
Belfast City Council Meeting
Tuesday, December 16, 2025

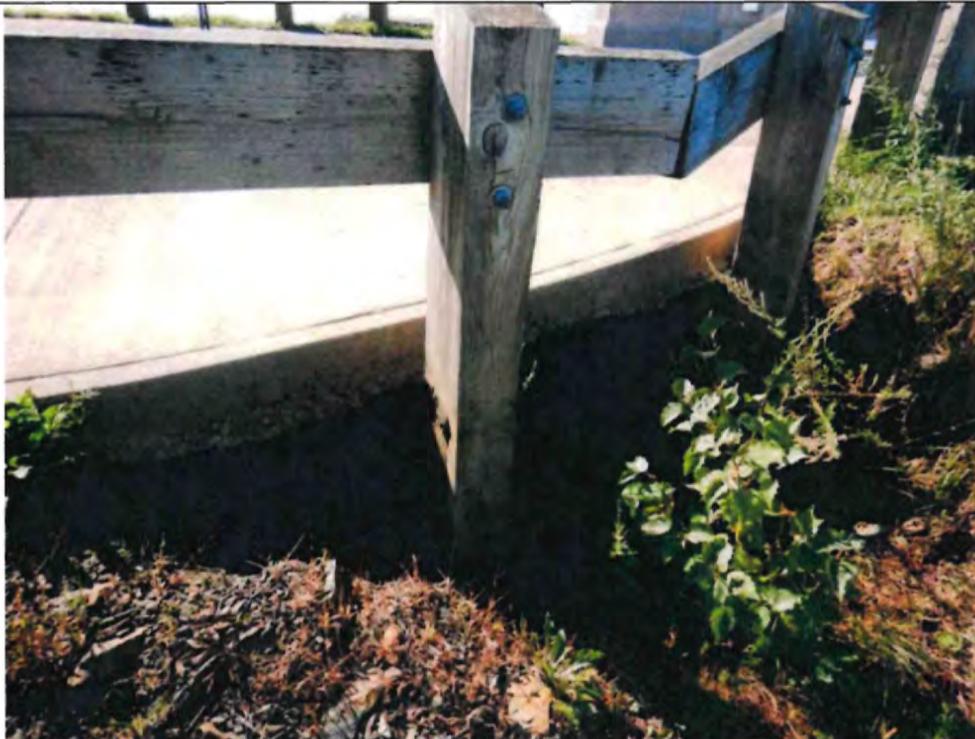
Photo No. 4 - 9859

Description: Undermining up to 9' long by 3' deep at the north side of the East Approach.

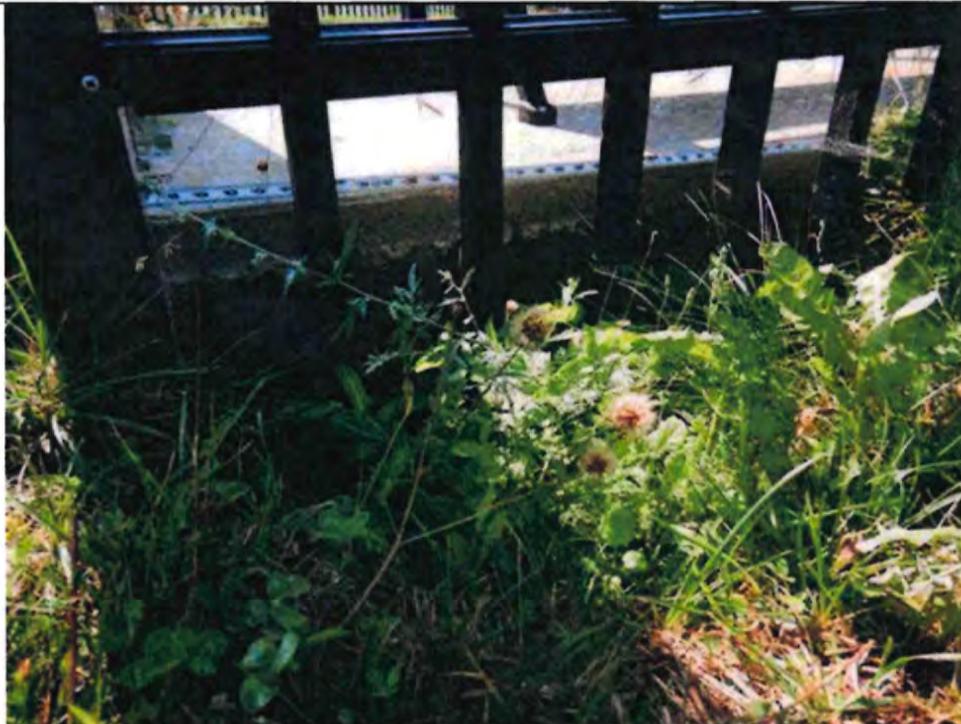
Photo No. 6 - 0128

Description: Undermining up to 3'-4" wide by 1'-6" deep at the north side of the West Approach.

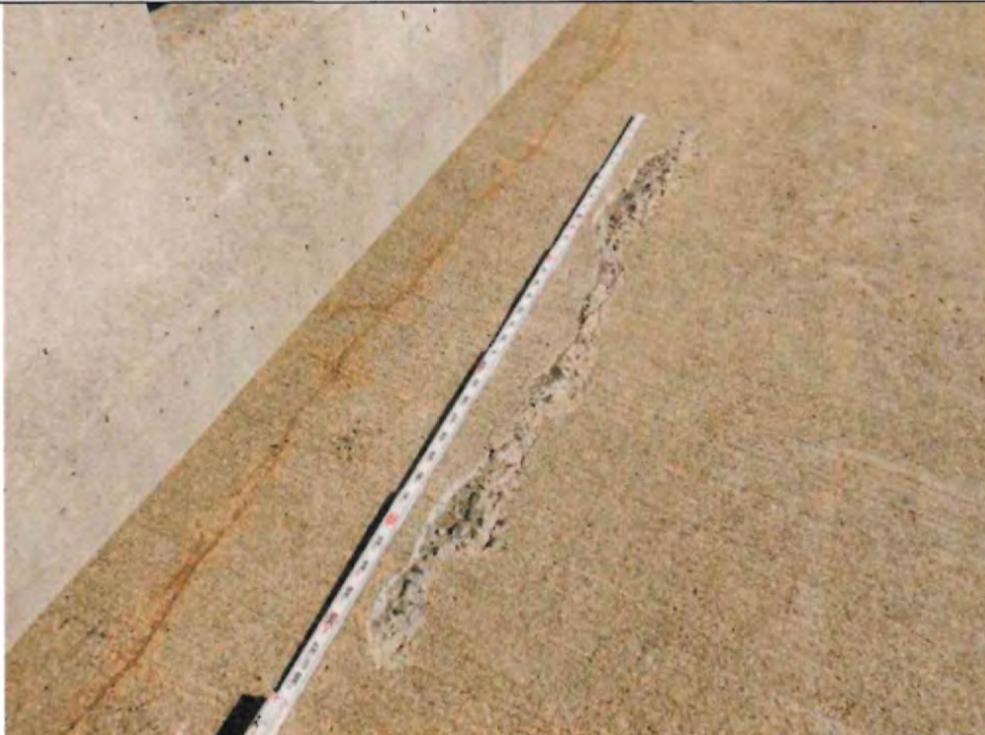
Photo No. 12 - 0029

The concrete deck surface is in good condition in all spans. There are scattered deck pop-outs up to 3" in diameter in Spans 4, 14, 15, and 16. There are hairline transverse and longitudinal cracks throughout the bridge deck. Transverse cracks are spaced 4'-12' apart. Spalls are noted up to 3'-1" long, particularly in Spans 6, 8, and 9. There is a spall on the north fascia of Span 14, approximately 1/3rd the distance to Pier 13. The galvanized steel stay-in-place deck forms below the deck are in good condition with corrosion noted due to previous leaks near joints, however no active leakage is noted.

Description: Deck spall up to 3'-1" long and longitudinal crack along the north rail in Span 9.

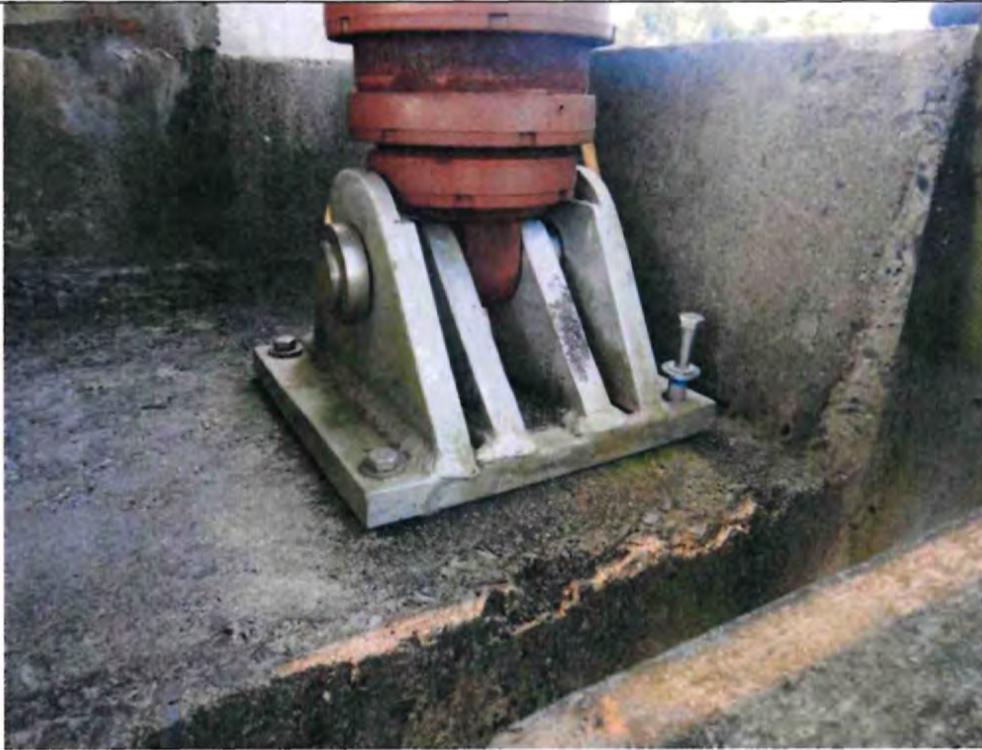
Photo No. 25 - 0238

Description: Failure of anchor bolt on sole plate of north lift cylinder on Pier 3A.

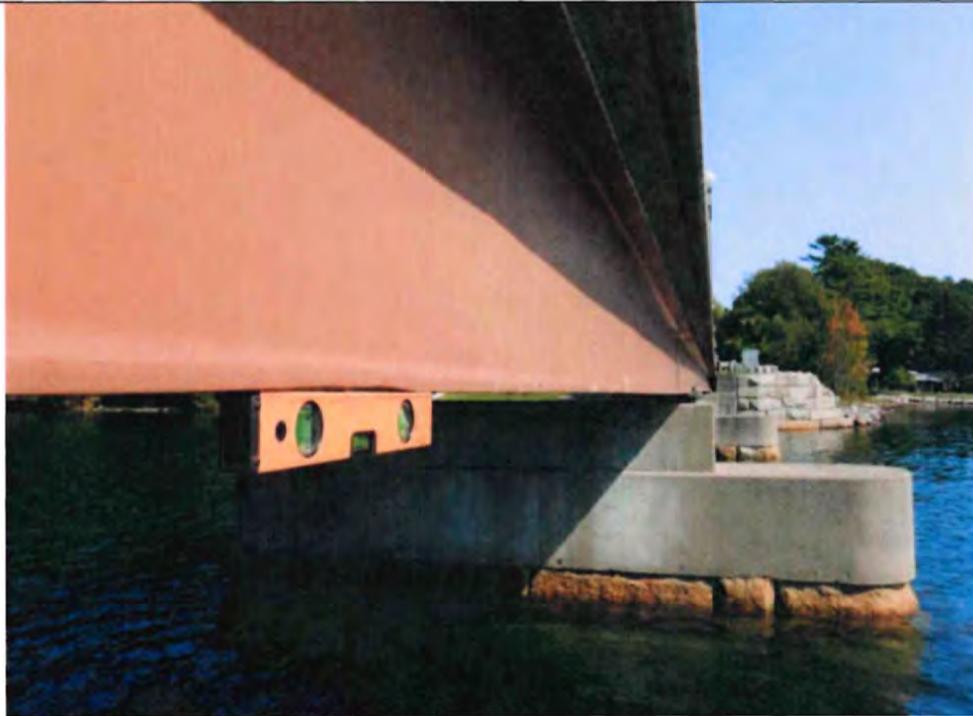
Photo No. 28 - 0164

The beams are galvanized and painted, and the diaphragms are galvanized. The paint and galvanized coatings are in satisfactory condition, with paint chipping and flaking noted on the bottom flanges. There is one minor area on the south bottom flange of the south beam in Span 11 with paint peeling. In multiple locations, steel was welded or torch cut during construction and not re-painted, causing corrosion. There is corrosion on the diaphragm connection plate to bottom flange weld, the beam bottom flange to sole plate weld, and at the bottom of the bearing stiffeners that were torch cut for the anchor bolts. In Span 16, at midspan on the south beam, there is an upward deflection of up to 1/4".

Description: Span 16 south beam with up to 1/4" upward deflection at midspan.

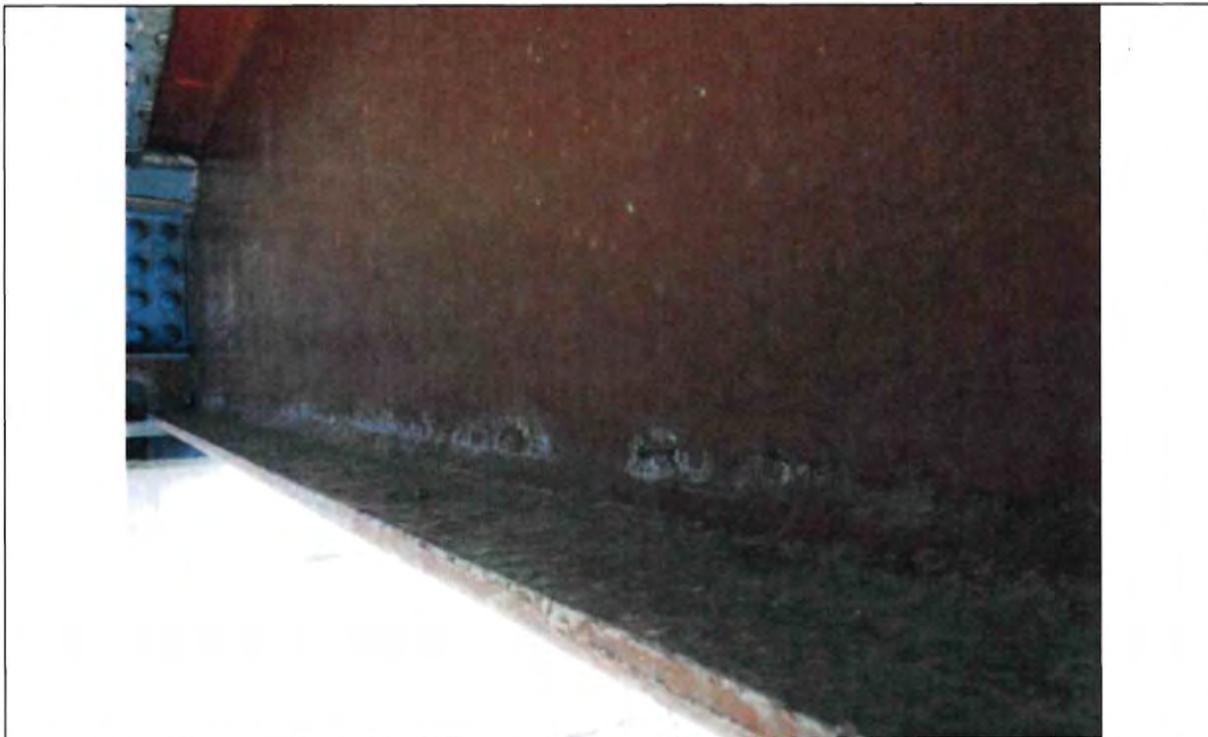
Photo No. 29 - 0152

Description: Paint chipping and flaking on interior bottom flange of south beam in Span 18.

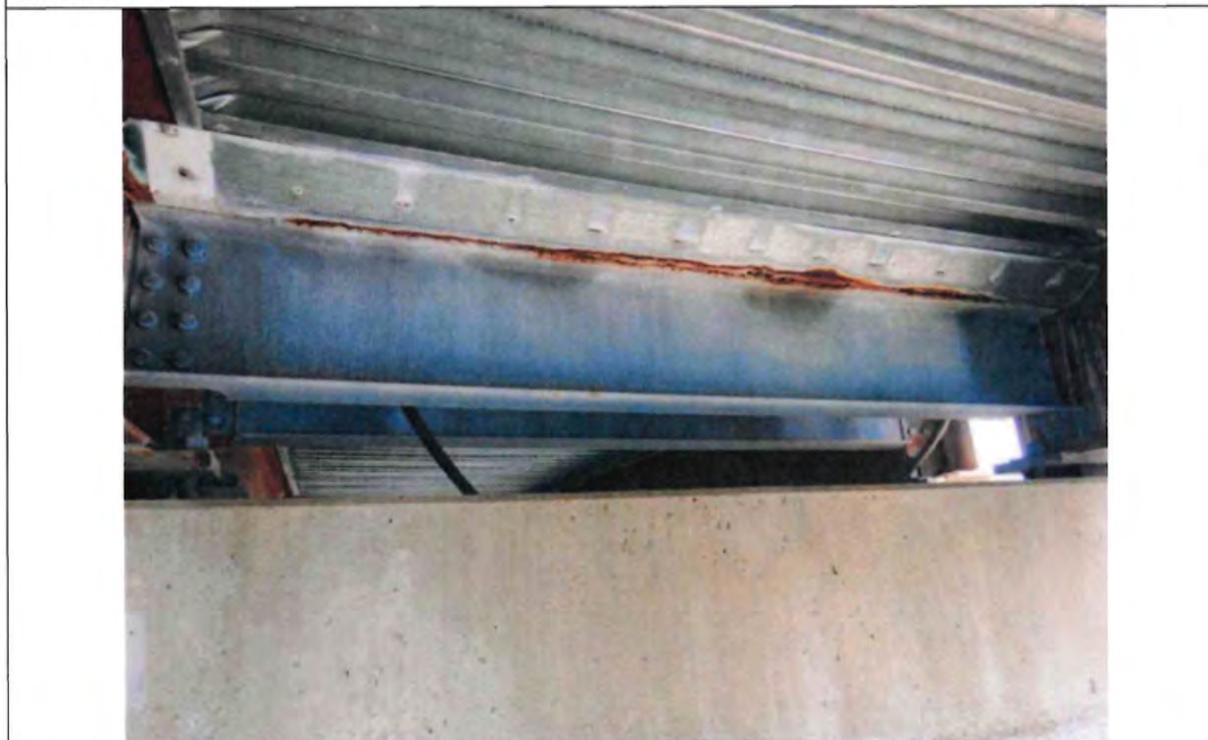
Photo No. 30 - 0219

The flexible joint sealant is sunk below the deck surface in multiple locations due to the failure of the backer rod at Piers 1 and 5.

Description: Failed backer rod causing corrosion and rust staining at the end diaphragm of Span 6 over Pier 5.

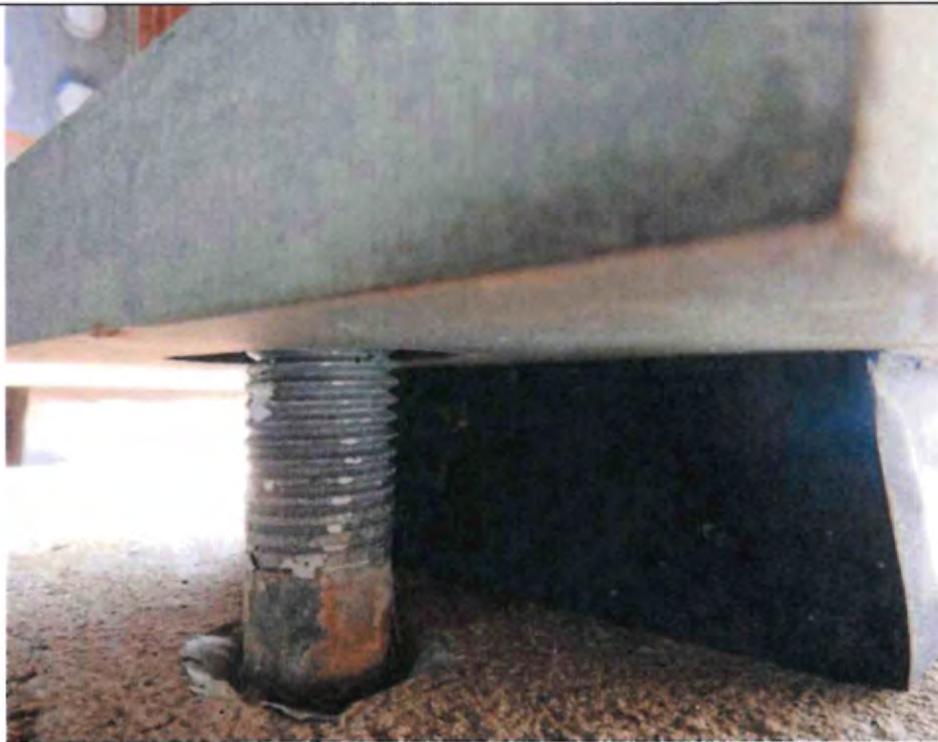
Photo No. 34 - 0215

Description: Up to 1/4" wide by 1/4" deep split in elastomer in south beam at Pier 6.

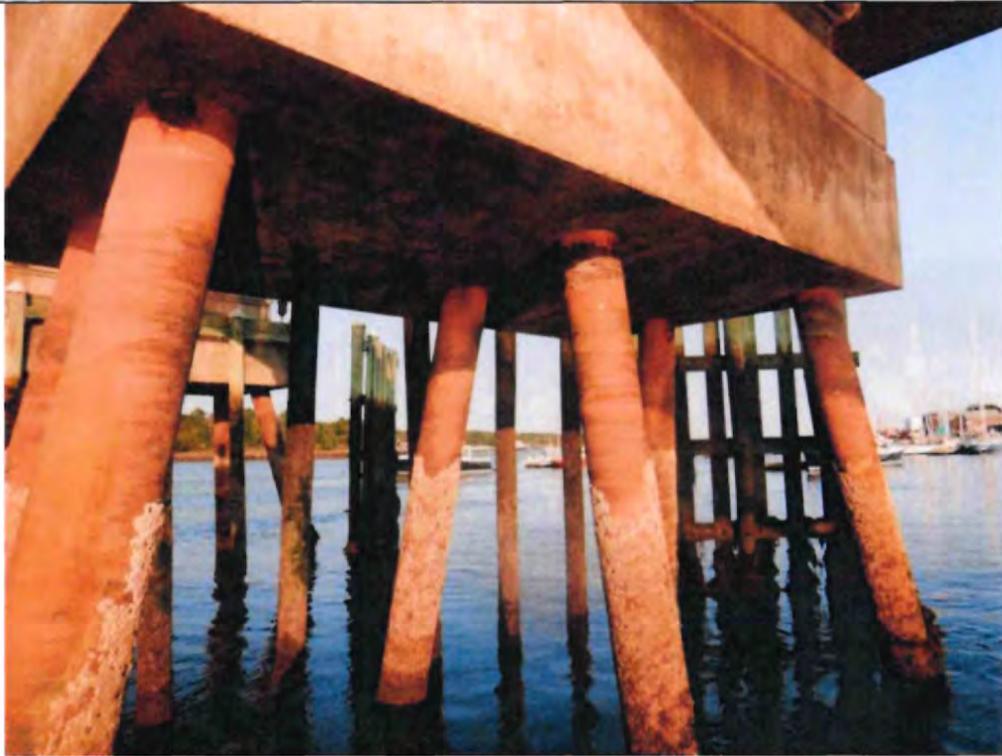
Photo No. 45 – 0340

Description: Scattered epoxy coating failures on steel pipe piles below Pier 3A.

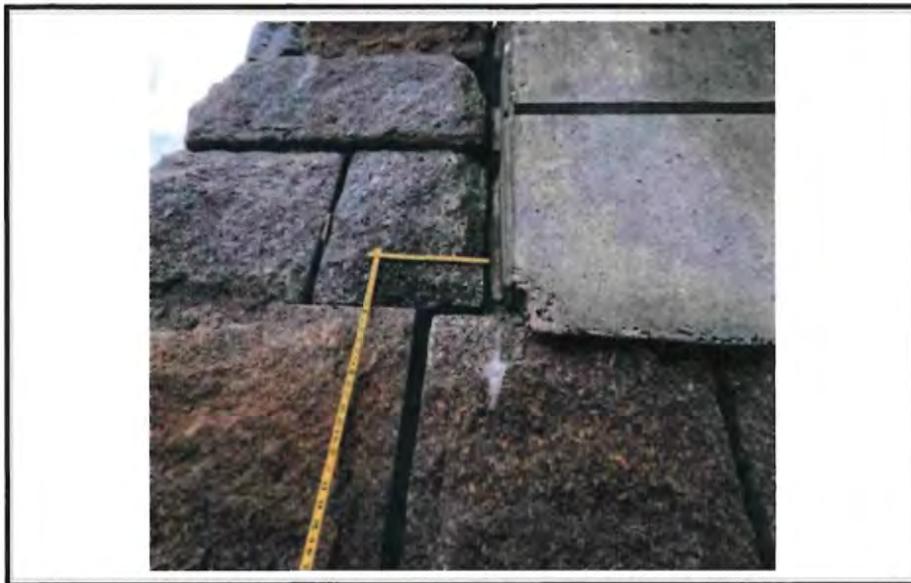
Photo 003

60.1d (Breastwalls): The breastwalls were found to be in satisfactory condition. Typical conditions include loss of pointing between the stones as was present in other areas. At the West Breastwall, limited movement up to 1" was observed between the concrete bridge seat and adjacent South Wingwall stones (Photo 3).

West Abutment, Breastwall: Note separation, 1"

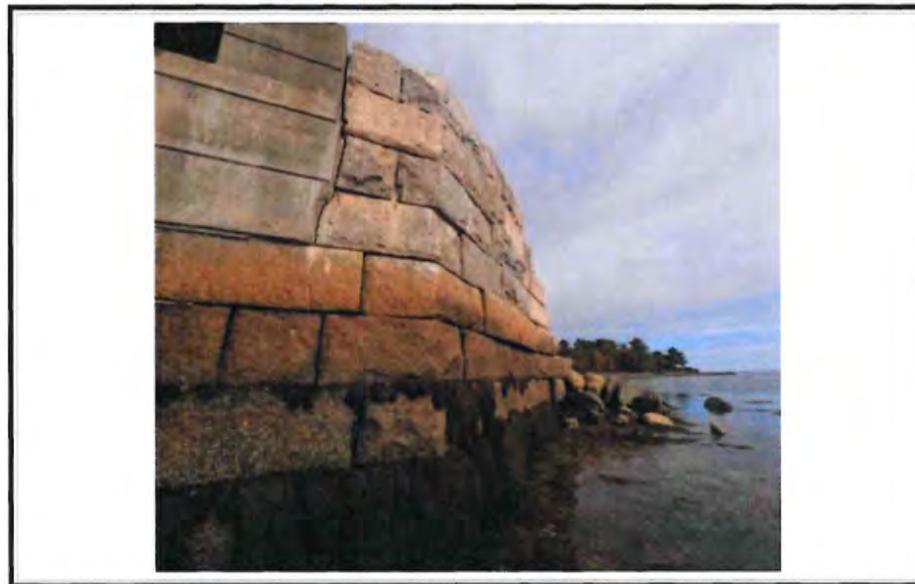
Photo 006

60.1e (Wingwalls): The wingwalls were in fair condition overall. Typical gaps between joints varied between 1-4" and pointing loss was observed throughout. Both wing walls on the East and West Abutments were found to have lateral movement. Both abutments exhibited signs of bulging in the upper 3-4 courses of stones. Lateral separation in the N/S direction was found between wing walls and the breastwall on both abutments. See Photos 2 through 8.

East Abutment, South Wingwall: Note separation of stone from concrete

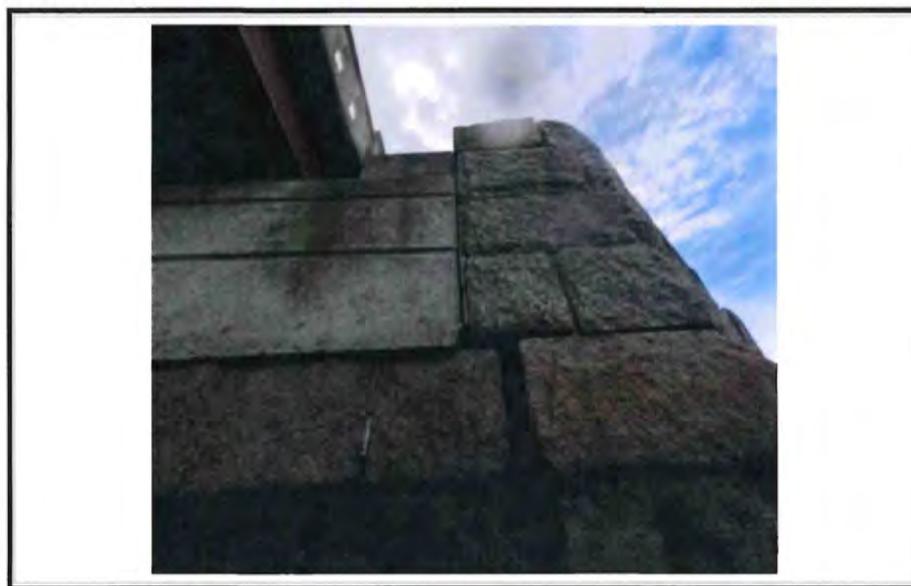
Photo 007

West Abutment, North Wingwall: Note separation from concrete

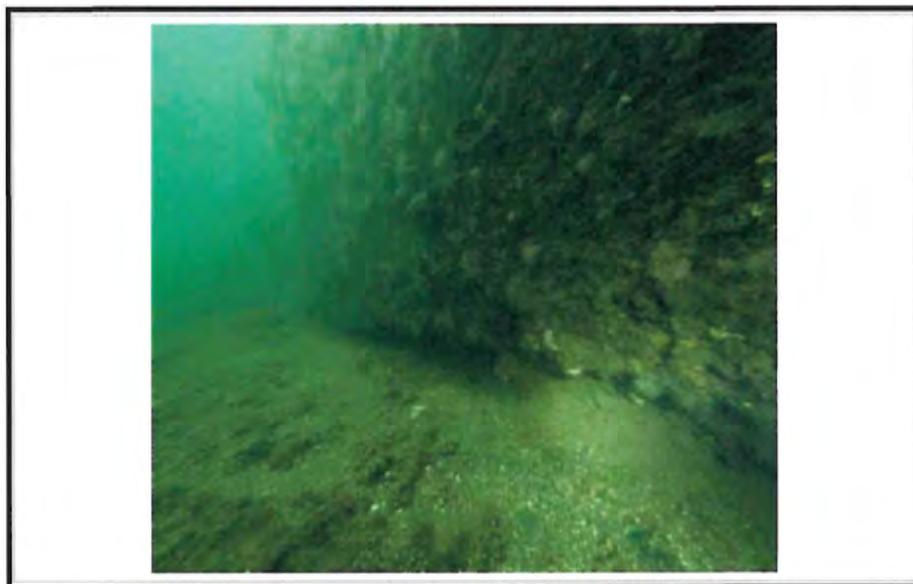
Photo 011

Pier 2: Undermining of footing

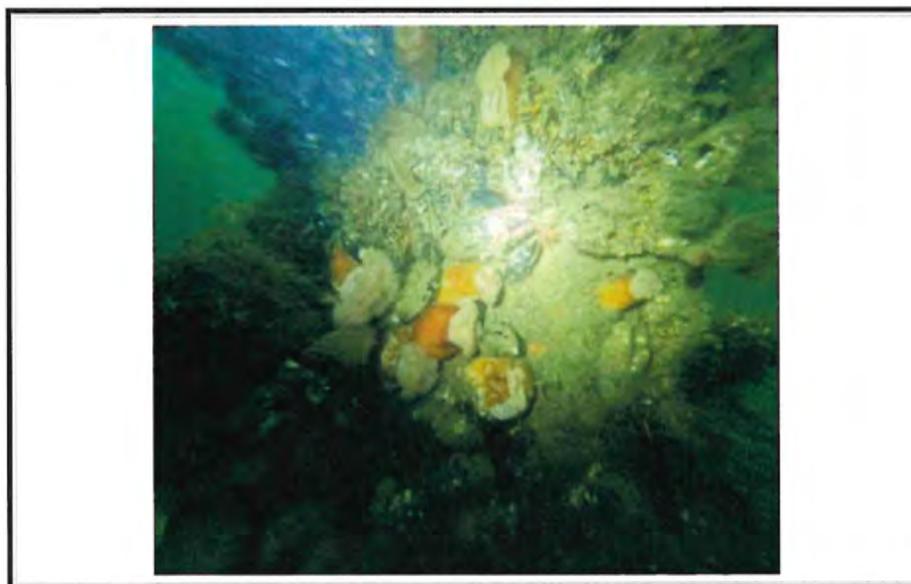
Photo 012

Pier 3A: Marine growth

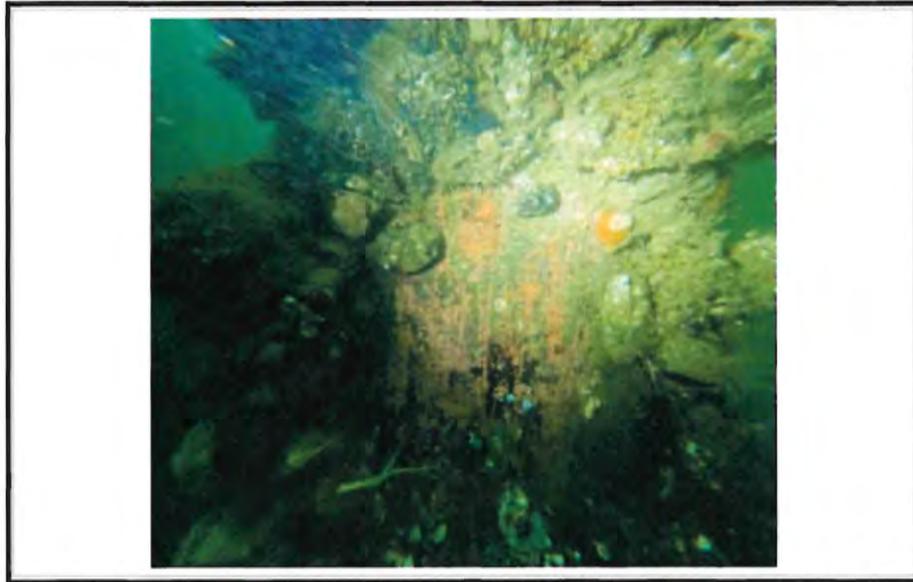
Photo 013

Pier 3A: Marine growth cleared

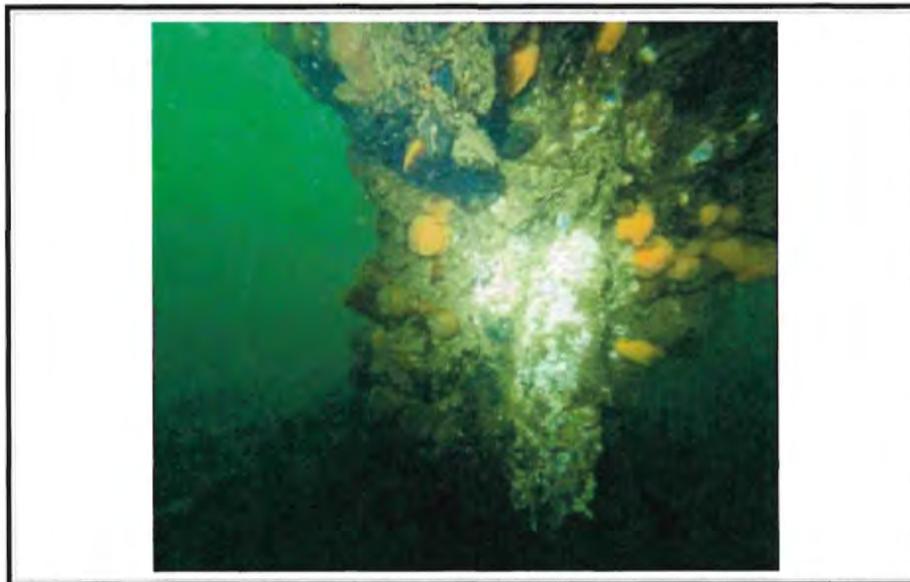
Photo 014

Pier 3A & 3B: Typical depletion of welded zinc anode

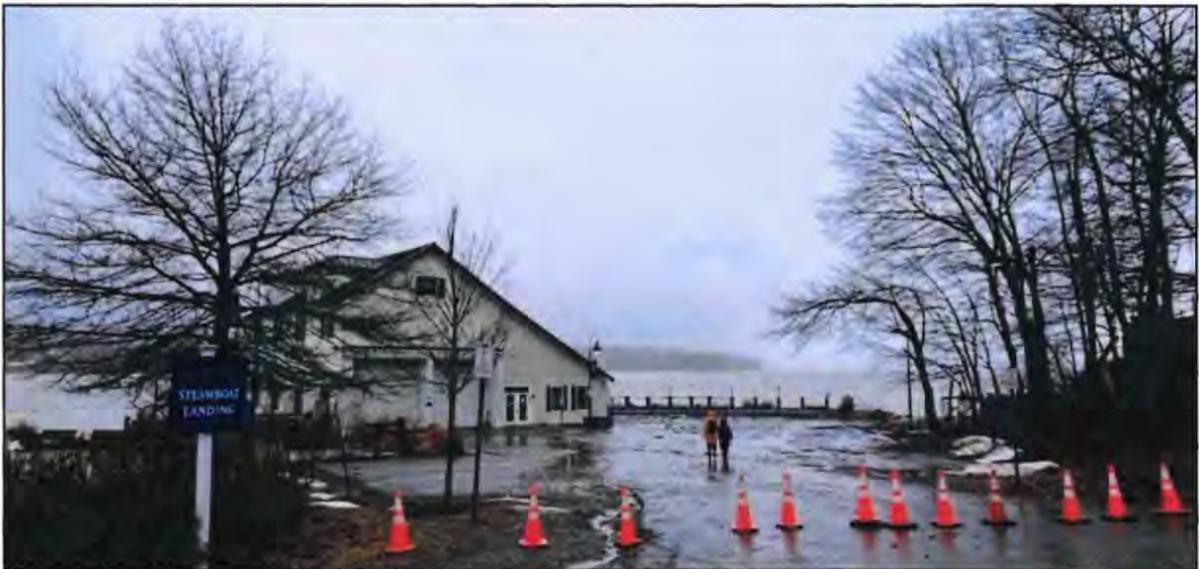
Figure 1-2. Belfast Boathouse flooding during January 2024 storm.

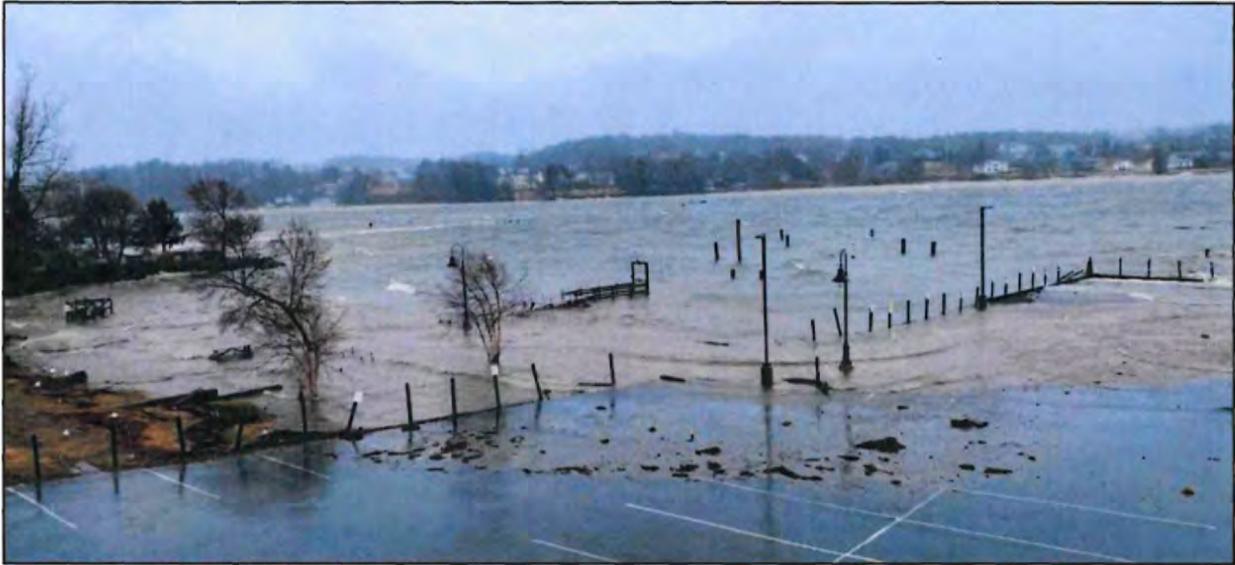
Figure 1-3. Flood conditions near Heritage Park during January 2024 storm.

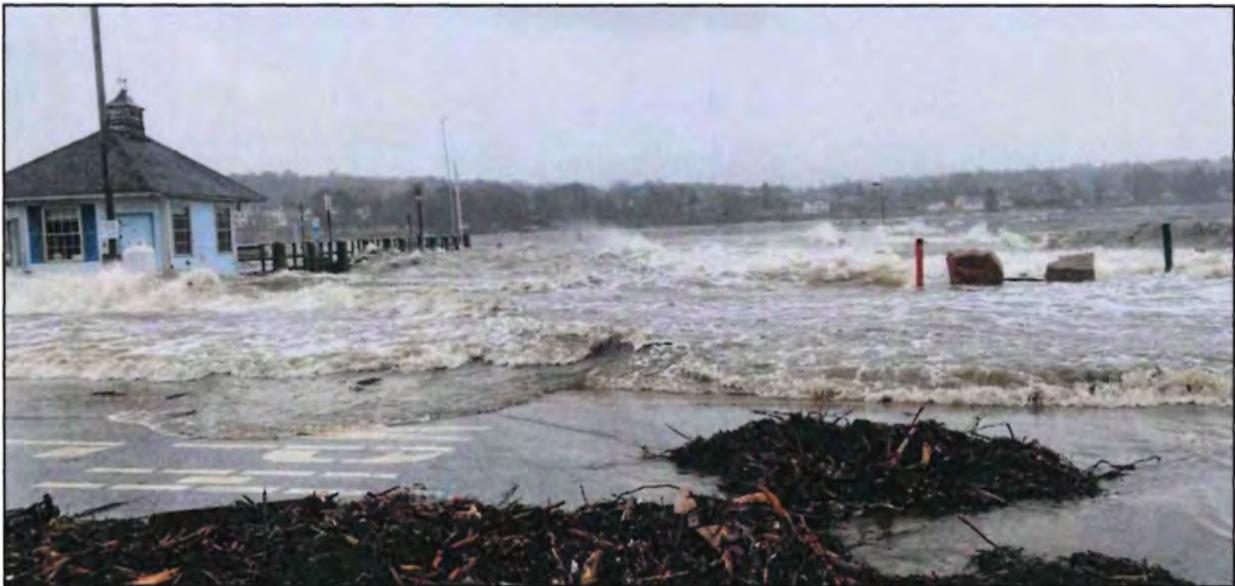
Figure 1-4. Flood conditions at City Landing during January 2024 storm.

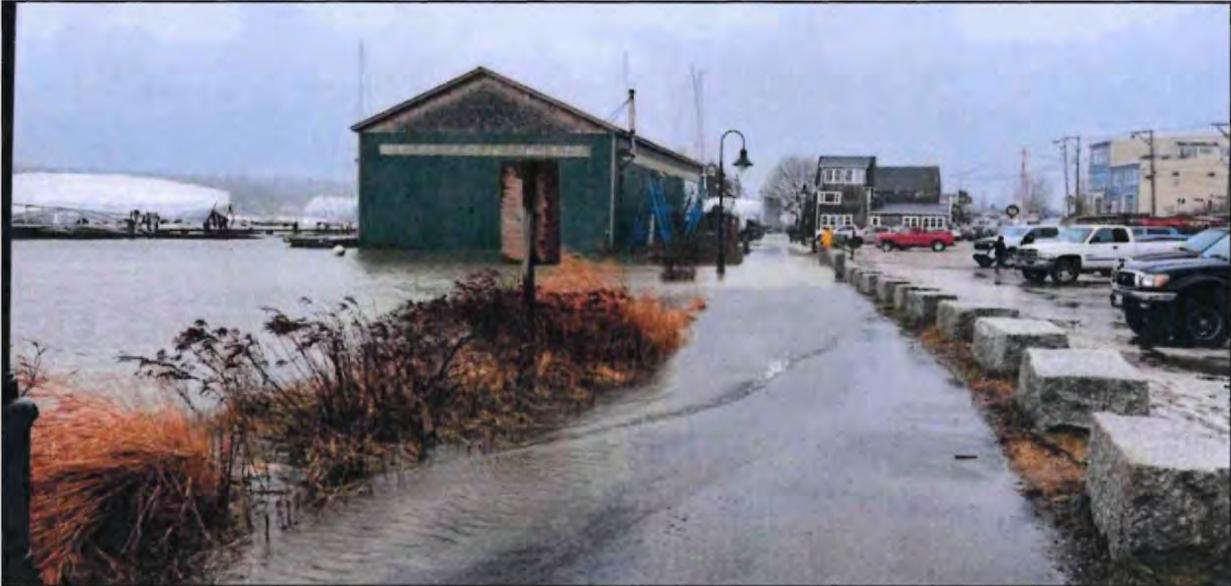
Figure 1-5. Flood conditions along Harborwalk during January 2024 storm.
